THE ROOT OF THE PROBLEM

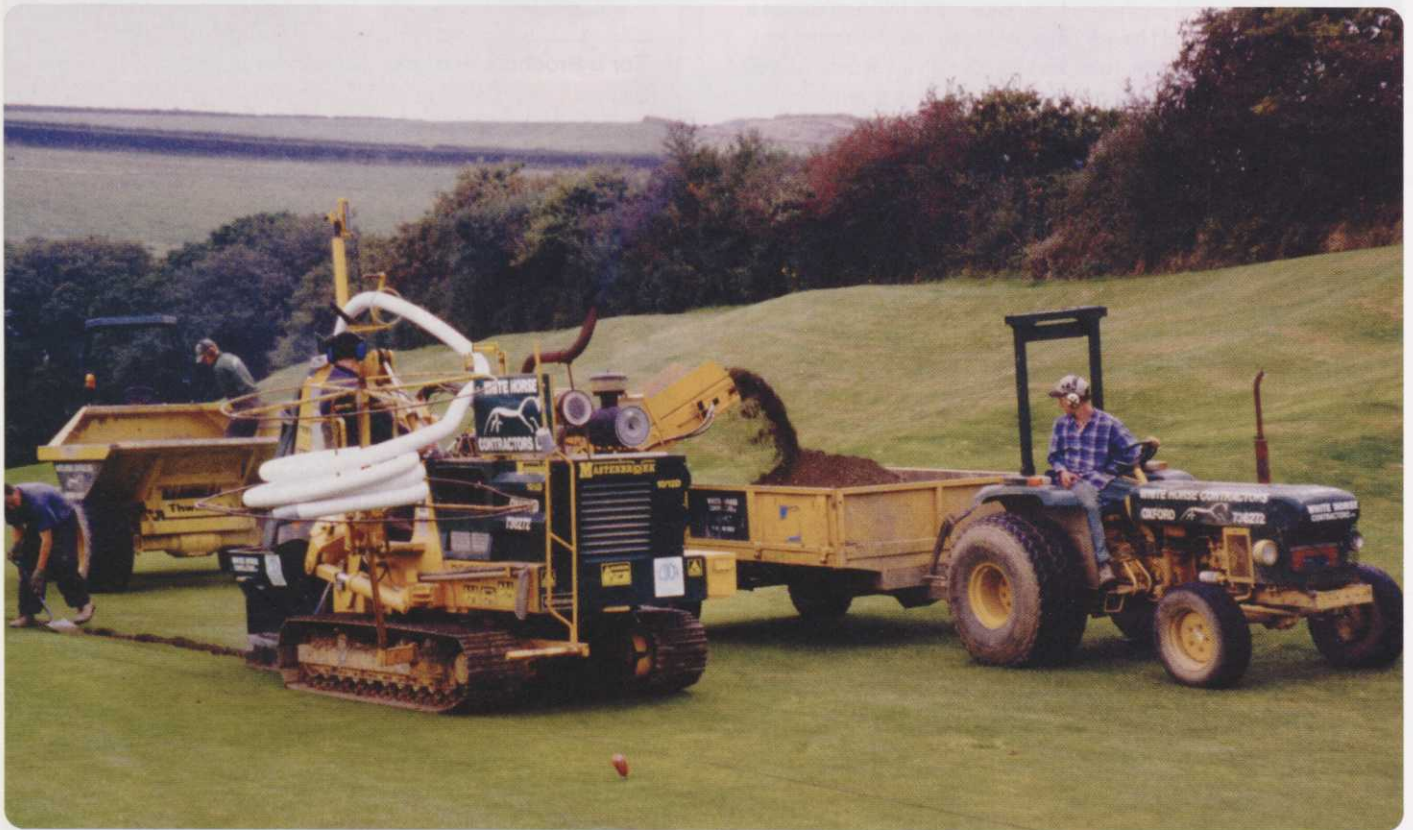
Roots enter the pipes as tiny hair-like structures. They grow quickly inside the pipe and can separate or crack pipe joints and eventually block the system. Because both pipes and roots are underground and out of sight Golf clubs are often unaware of root

So what can be done? One option is to cut the roots in the pipes or rod the pipes to clear blockages. This is only a temporary measure, as this often encourages faster thicker re-growth. Nigel Law, Contract Supervisor for White Horse Contractors tells the story of a recreation ground in Reading where the company had been asked to review the drainage and establish the problem. A wet spot was identified in the field and small-scale excavations took place, which showed the roots had attached themselves and entered the drainage pipe. The only course of action on this occasion was to cut the pipe and remove a section and pull the roots out, this was quite remarkable as the roots were removed in a single piece measuring 12-meters and 100mm diameter, the size of the internal pipe. On this occasion the pipe was replaced and rejoined.

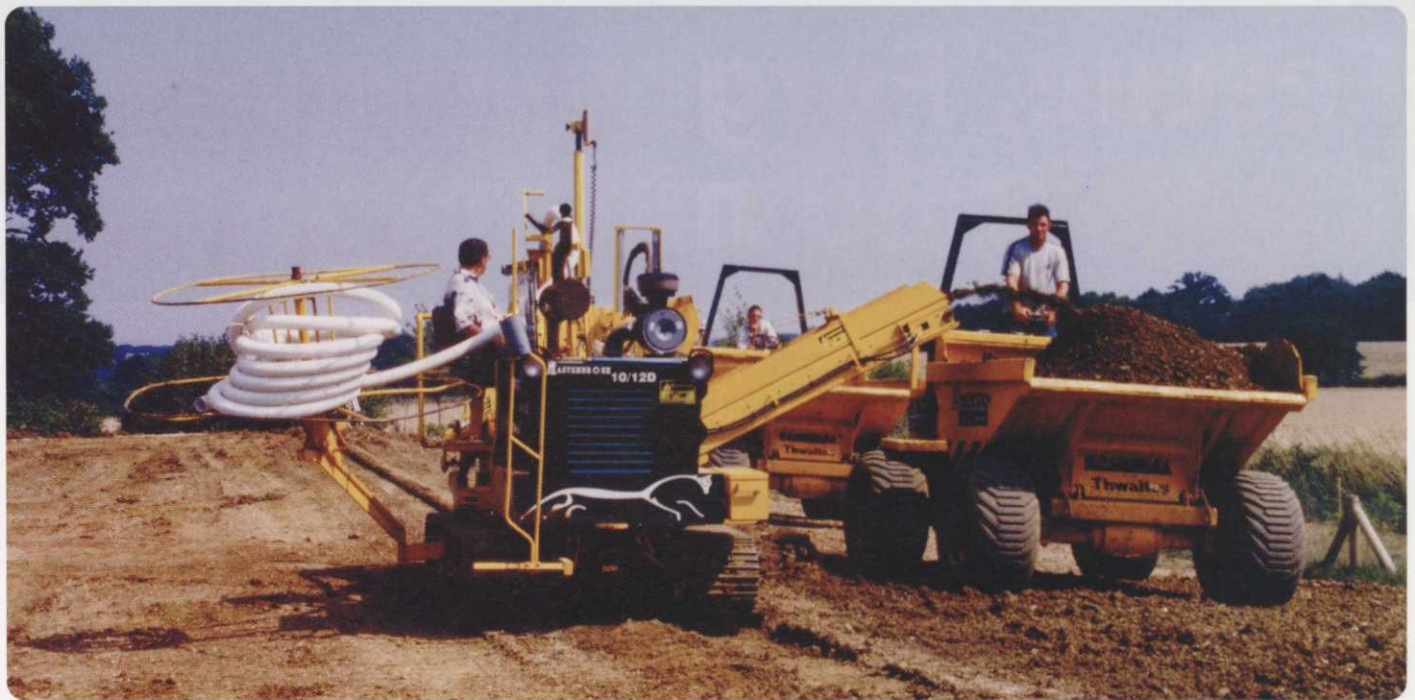
invasions until serious and costly damage has occurred.
