Be Prepared!

At the first hint of spring, golfers are ready to play but are you and your sprayer prepared for that first outing? Richard Fry finds out...

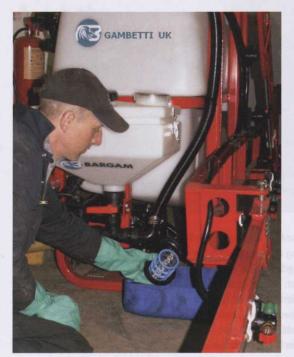
Pre-season checking of filter for cleanliness and damage

Before any spraying is undertaken ensure that a thorough check of the machine and equipment is carried out and make a quick risk assessment: Is the sprayer secure, is the PTO shaft guarded. Other checks should assess nozzle wear and spray output (only check with clean water), the condition of the pipes and hoses, filters and pressure gauges.

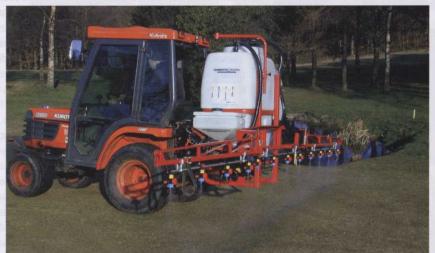
When spraying close to water ensure that LERAP guidelines have been followed and the correct nozzles have been fitted

Spraying should only commence when climatic conditions are favourable and particular care should be taken when spraying in the vicinity of lakes and drainage ditches. Local Environmental Risk Assessment Practices for Pesticides (LERAP) should be adhered to in such situations and low drift nozzles fitted to machines, at least one sprayer manufacturer Gambetti fit these nozzles as standard to all their amenity sprayers.
