Anatomy of a lake:

One club's answer to water shortages

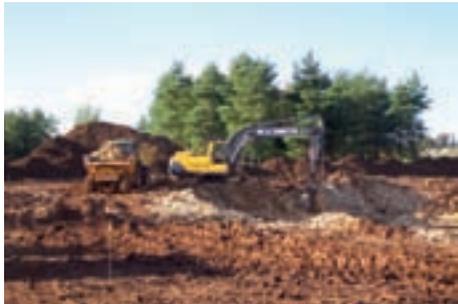
The contractor was responsible for marking and setting all outlines and levels to the Architects plan and satisfaction. Digging commenced with rotavating and stripping the topsoil on the lake site – 6000 square metres - and the additional 10,000 square metres for dumping the spoil. The dig started by digging a long trench down the middle of the lake to the

correct depth. The machine used was a 21 tonne Komatsu 210 Excavator. A 12 tonne 4WD Dumper, and a 12 tonne tractor and dump trailer were used for transport. A 14 tonne Komatsu 140 excavator was also on site for stripping and shaping. The material coming out of the dig was predominately large angular Cotswold Limestone, but a certain amount of small underlying material was salvaged to help line the completed lake – this material was moved to one side and saved. The Cotswold stone was mostly soft enough to dig without significant difficulty and the dig progressed quite rapidly, with the operatives working from 7am until 5.30 pm. As each mound area on the course was filled with rubble, the 21 tonne machine clattered across, tracked the stone in, and shaped to the architects satisfaction. Topsoiling was on-going while further excavation continued. Topsoiling was carried out using a 5 tonne TB 145 digger and

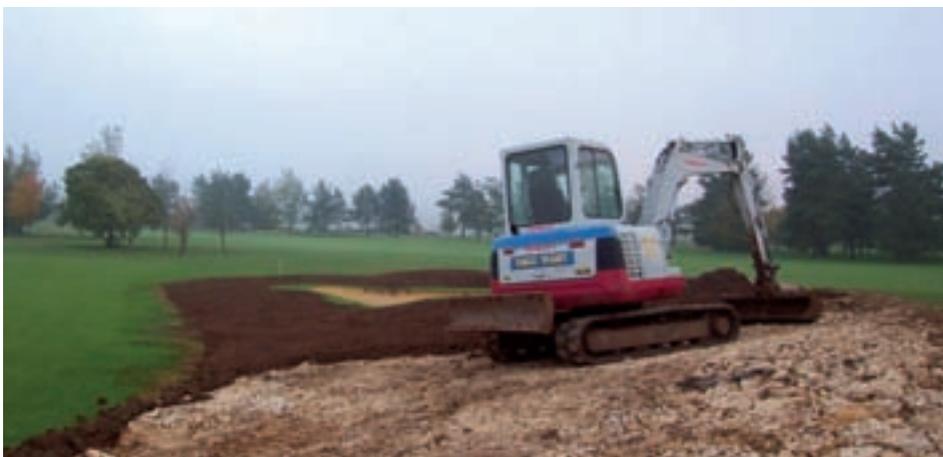
6 tonne dumper. Turfing and seeding commenced straight away as each area was completed. The decision, on budget grounds, was taken to seed the outside of the mounds, and turf the inside slopes to speed up development.

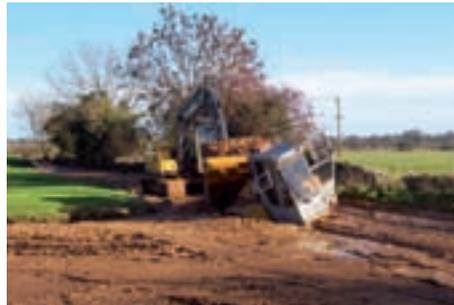
The weather was mainly appalling with torrential and prolonged rain making the ground somewhat tricky in places.

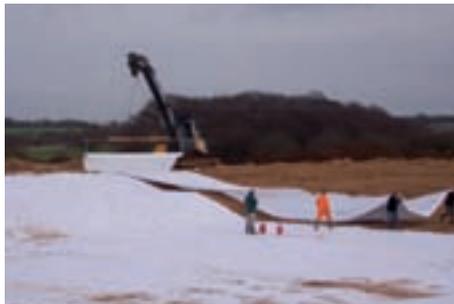
With the lake dig completed and the depth checked by laser, the small material was put back around the sides, safety shelf, and base. A trench was then dug around the top to take the lining fabrics which would be required to waterproof the lake. Enter stage left – GeoTechnical Services to line the lake. The lining consists of three layers which are laid in 4 or 6 metre wide strips. Each strip is welded with a heat gun to its neighbour, as it is laid. An underlay, which is like a very thick felt with a cushion effect, is the first layer. This protects the middle layer, which is the impermeable (waterproof) part. A

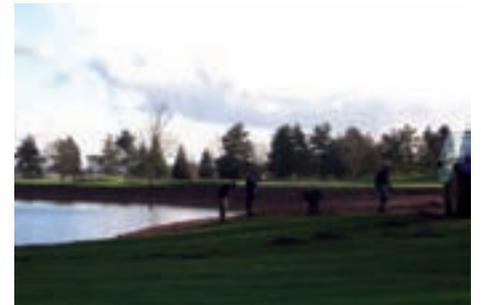
further layer of felt overlay completes the job. All these materials are tucked into the trench around the top, and backfilled. This took a week with four operatives puffing up and down the slopes towing each strip of material by hand (or by foot in this case). It looked like extremely hard work and I was quite glad not to be involved.

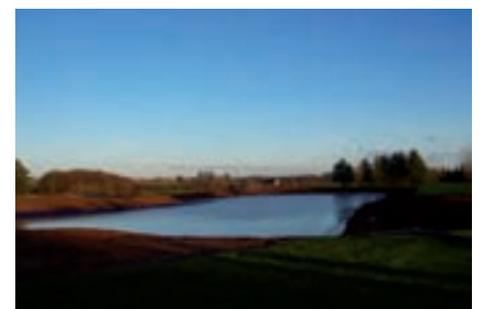
Finally, the topsoil was laid around the lake and down to the bottom of the safety shelf and all haul routes were repaired “on the way out”. Believe you me, I’ve never been so glad to wave goodbye to anyone ever. The relief didn’t last long however, the entire bank which measured 330 metres around and was between five and 15 metres deep had to be prepared and turfed. Enter the MGC greenstaff who deserve medals for their efforts and despite the very worst the weather could throw at them somehow got the job done.

47.5 pallets of turf, some of which were laid in gale-force winds and driving rain, were imported from Teal Turf at Worcester, who responded magnificently lifting and delivering at 24 hours notice during brief windows in the weather. A budget of £160,000 was set, and in the event, this was exceeded by £4000, which was well within contingencies. Having rolled the banks, the lake now looks totally natural, planting with reeds and aquatic plants will be on-going, and the members have applauded the foresight of the committee in sanctioning the project.
