# Surviving The 2004 Spring Floods

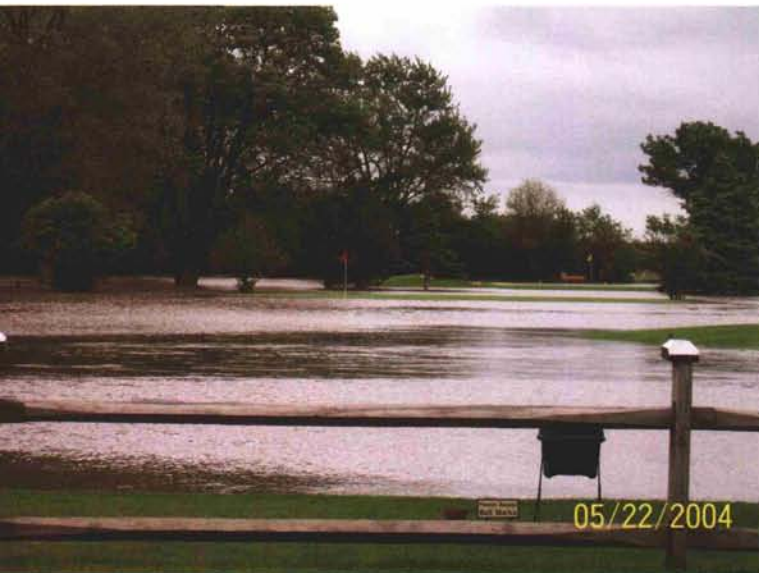
*Par-3 10th hole from the tee box. The Kishwaukee River, which is just beyond the tee, is now part of the golf course.*

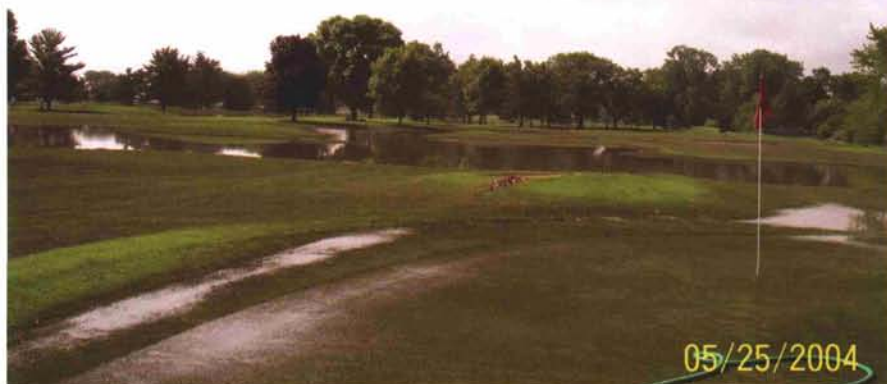
Water recedes from the 18th green, leaving muddy turf and cornstalk debris behind.

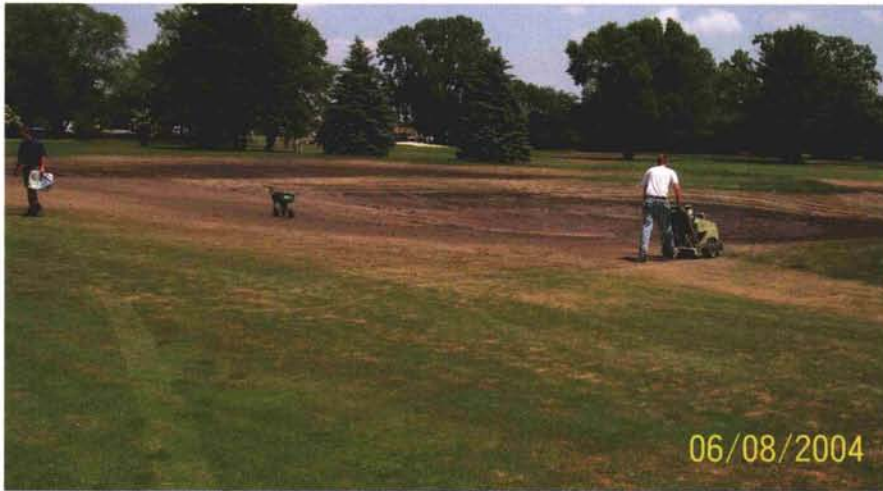
The recovery process begins: slit-seeding and fertilizing dead turf areas on the 18th fairway.

We used three different slit-seeders to do the seeding. A Ryan Mataway walk-seeder was used on all bentgrass areas and on some sloped rough areas. We put down a pound to a pound-and-a-half per thousand square feet of Penneagle seed at two different angles in the fairways. No dead turf material was removed; the slit wheel on the seeder cut through

the dead material and surface mud, so the seed was actually secured by this dead turf. The seeding worked best when the surface was moist, so the fairways were seeded first as soon as the conditions were dry enough for the Mataway to operate. After the fairways were seeded, we spread a moderate coating of sand topdressing over the repaired areas to help protect the seed from washout and to aid in germination.

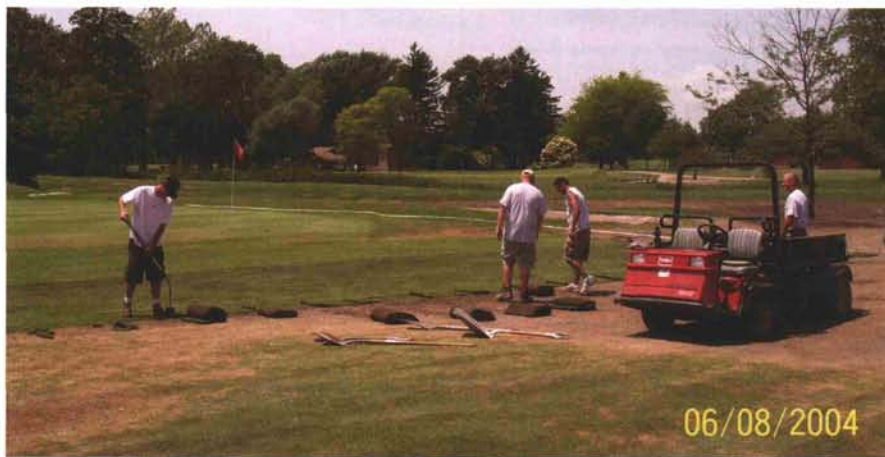
*Sodding no. 11 approach with Penneagle bentgrass from the homegrown nursery.*

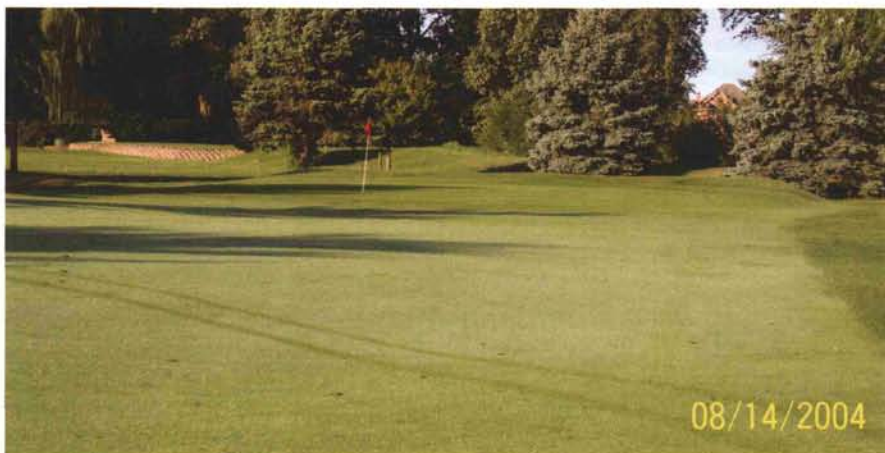
*Back to normal: no. 11 approach two months later!*

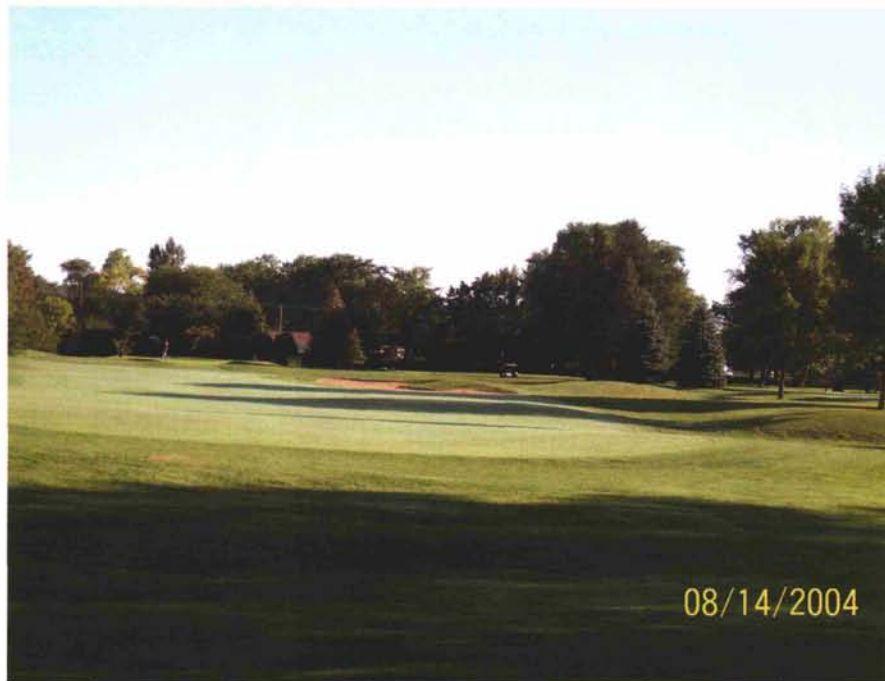
*View of the newly seeded 18th fairway two months after the floods.*
