Wynstone's Ted Fist Takes Innovative Approach to Bunker Drainage

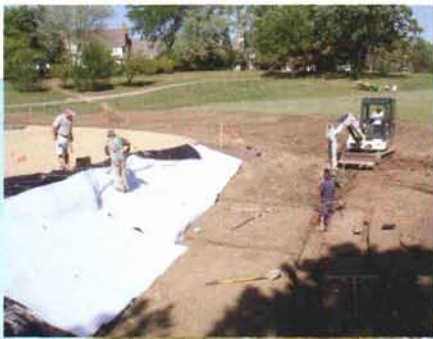
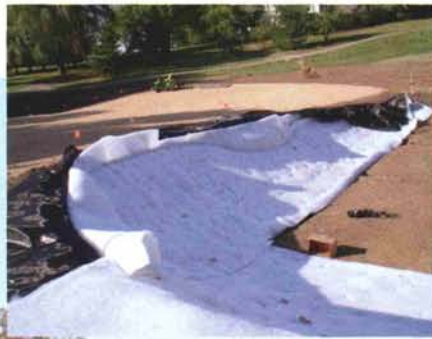
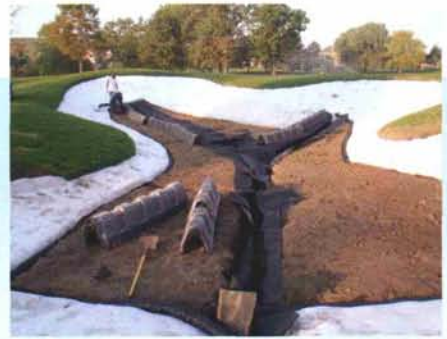
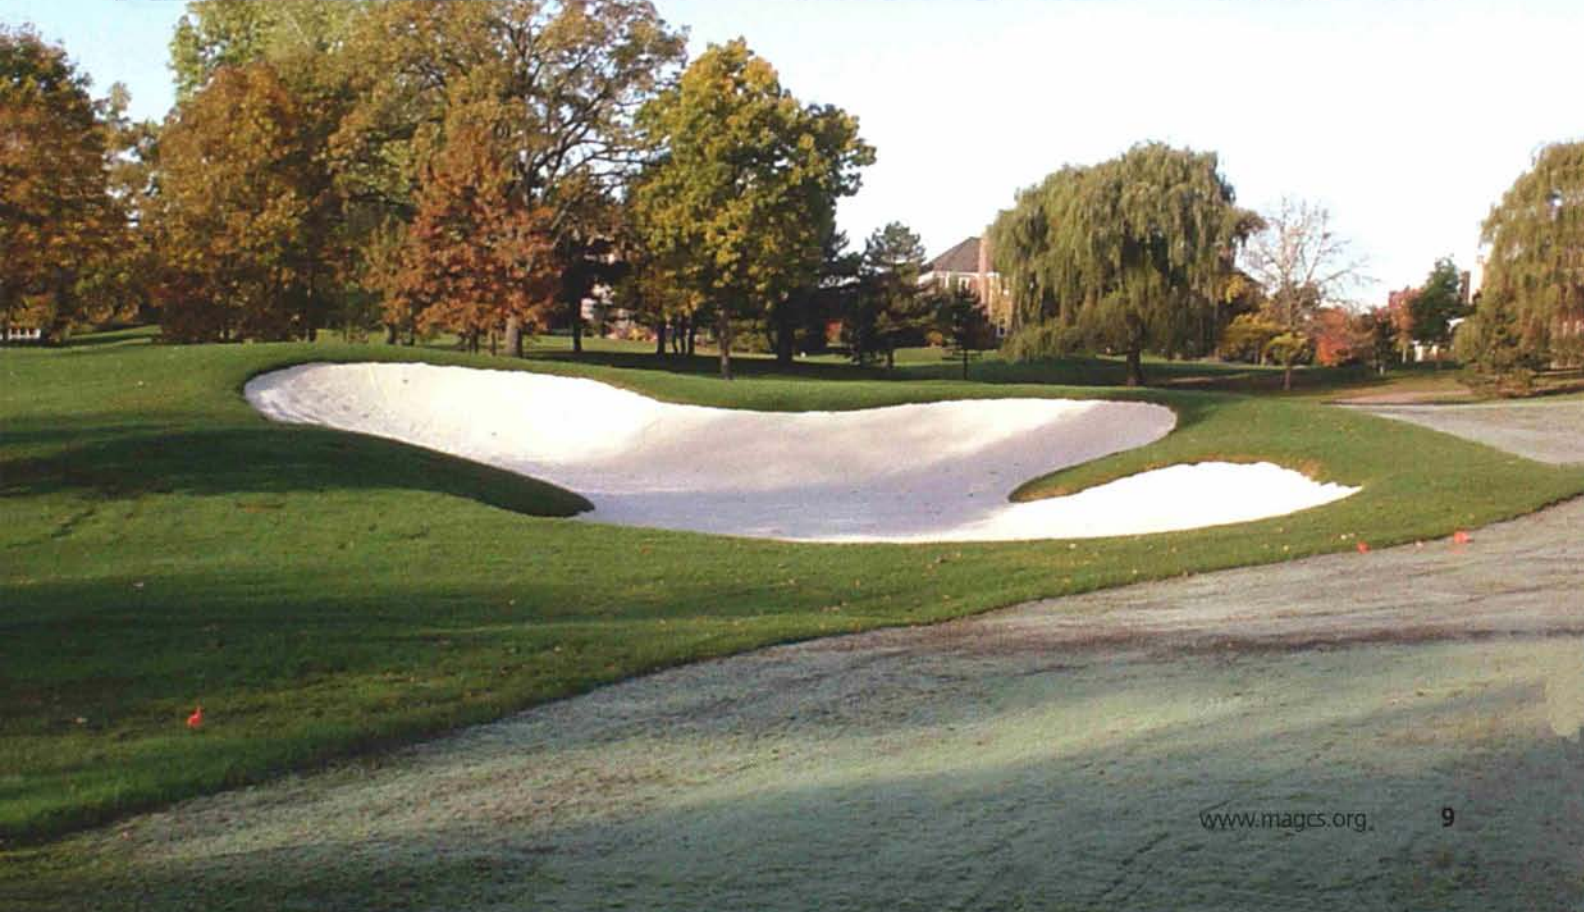
Two layers of fabric material were used inside the bunker cavity: the first layer on the bunker floor is Mirafi Filterweave 402, a woven monofilament liner, that will keep clay from migrating upwards into the sand. Over this layer, Ted installed Sand Mat liner for erosion control of the sand.

No pea gravel was used to fill in the trenches. Instead, Ted chose to use an ADS product called BIO2 Diffuser which comes in pieces 15 inches high, 12 inches wide, and 87 inches long. The BIO2 Diffuser was placed into the drain trenches as a chamber system. The outflow drain pipe was connected to the BIO2 Diffuser. Ted explains, "the price of the sand was so high (\$78 ton delivered) I felt this was a good way to cut costs, and to also eliminate the possibility of pea gravel from migrating into the new sand."

The newly remodeled bunkers were filled with Pro-Angle sand at a depth of six inches at the base and approximately two inches on the edges and high flashes. Ted states that "so far the bunkers have not washed out at all even with the heavier rains that we have had this past couple of months." With the success of this innovative approach Ted plans to eventually use this system in every bunker on the golf course.
