## TECHNICALLY SPEAKING WITH

Ted Soenksen, *Wilmette Golf Course*

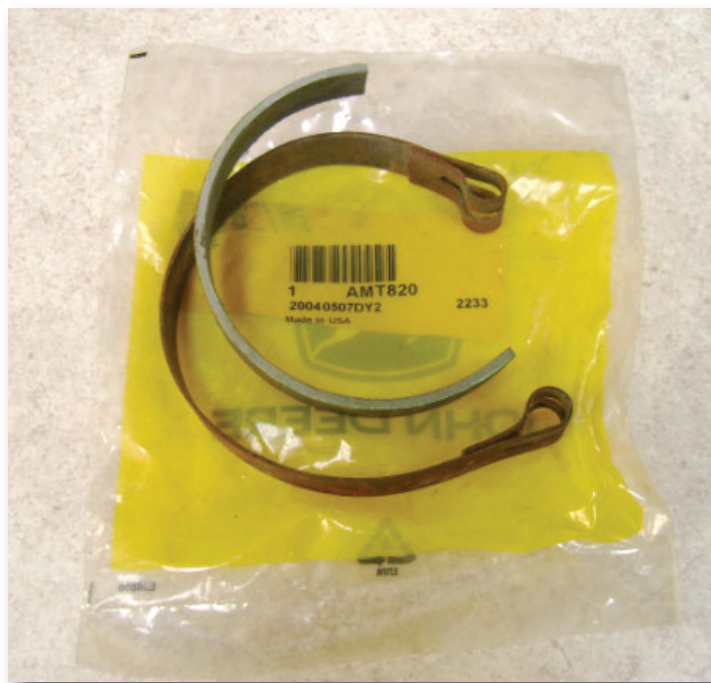
**Equipment:** John Deere walking greens mower model 220B

**Problem:** It suddenly developed a vibration and audible metallic chatter. It happened first time out in March after being completely serviced last winter.

The clutch engage lever would release because the machine vibrated so badly. The forward motion would abruptly slowed down on an incline, yet reel continued smoothly, and engine lugged a little but not die.

After taking belt cover off, it was seen that the brand new brake assembly installed in November failed. The adhesive did not hold the brake lining to the band leaving the lining free to chatter and lock up at will.

**Solution:** Replace brake band, and always keep one in stock.

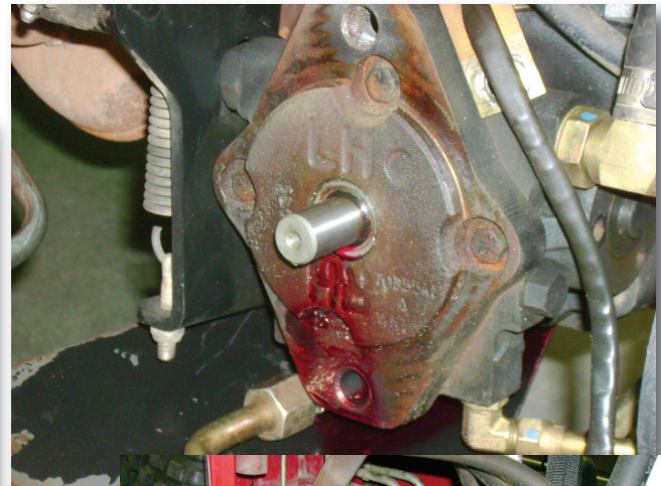
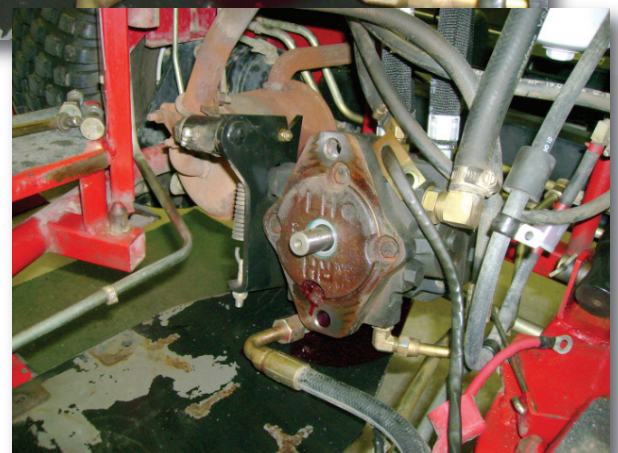
**Equipment:** Toro Sand Pro (or any other piece of equipment with hydraulics)

**Problem:** Hydro pump output seal was damaged when reinstalling engine. While repositioning engine coupler assembly, accidental damage occurred to seal with a screwdriver. Unfortunately, the leak was noticed after engine installation was complete and test start up.

**Solution:** Though, I did not actually cause the damage, it was still my error in not watching over a helper that was doing the work. Never pry against a shaft seal with screwdriver or similar tool to slide the coupler or pulley assembly to for alignment.
