## Westmoreland

Luke Cella, MAGCS

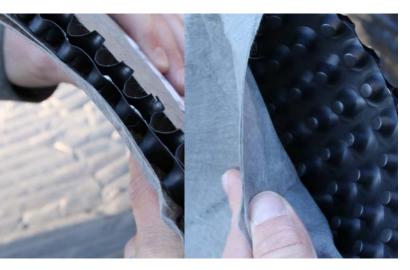
Over 11 miles of the waffle drain pipe was installed throughout Westmoreland Country Club. The two pieces of plastic are wrapped by a geotextile fabric.

have been installed as part of the project. Some of the basins are cylindrical while others are rectangular depending upon the need of the specific site. The other key component that is terminated into these basins, and larger sump pits, is the actual subsurface drainage. The piping system that was installed utilized a waffle drain, a system that has a core of two pieces of plastic wrapped by a geotextile fabric. This type of piping provides a greater collection area for water to enter the flow area than conventional round perforated pipe.

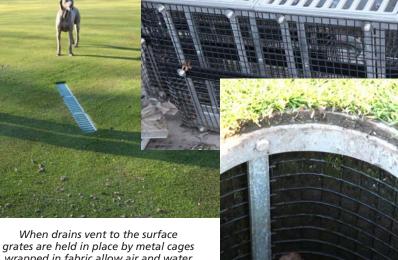
wrapped in fabric allow air and water exchange from the surrounding soil too.

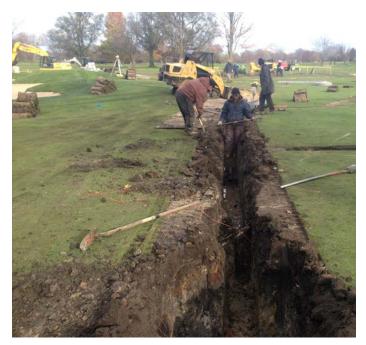
All the soil was removed from each trench cut on the property and backfilled with sand.

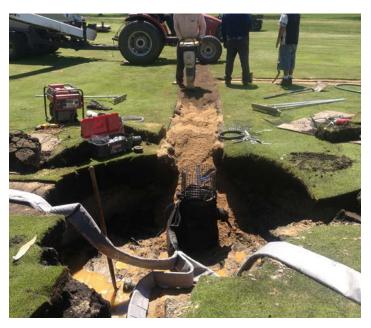
The Leibold construction crew compacting sand in one of the trenches.

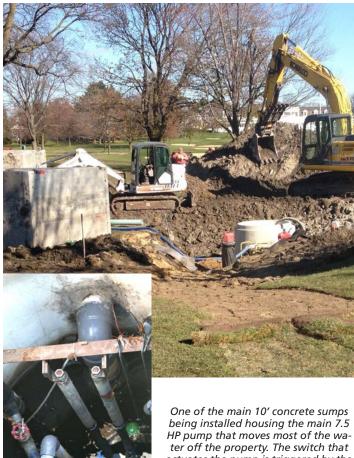
actuates the pump is triggered by the weight of the water within the sump.

Larger structures installed include sump pits (both concrete and plastic) where large amounts of water are collected and pumped back to the irrigation ponds on the course. One pit has a 7.5 HP motor-driven pump that is actuated by the

weight of the water within the pit. If electricity fails, there is a back up generator connected to this pump. In a couple of areas where it was too expensive to run electricity for pumps, Irrigation-Driven Pumps (IDP) were installed to push water to holding ponds. These pumps utilize the energy of the irriga-
