# Get Pumped!

## Case Studies in Pump-Station Replacement

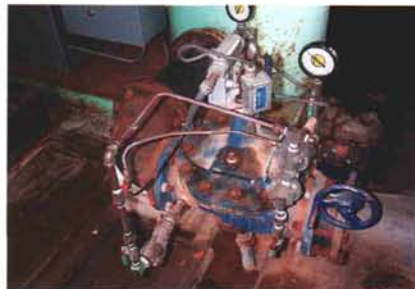
After studying our system in detail, the consultant made a number of recommendations. One of them included replacing the pump station. As was the case with Shoreacres, a primary concern was the integrity of the hydro-pneumatic tank. The pressurized tank displayed sections of rust and deterioration that could potentially result in the tank rupturing and injuring people in the building.

Inside CGC's old pump station.

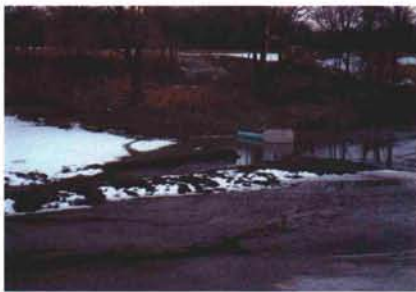
Many factors come under consideration when selecting any product. Service, reliability and peer recommendations are always very important. The designer builds the size and specifications into the station. Shoreacres required a station that would work with the present system and be able to meet the needs of the new system. Water quality was also an issue at Shoreacres. Water drawn from Lake Michigan will contain zebra mussels that clog pipes and pumps. Silt is also an issue. The cleaner the water source, the less wear there will be on the pumps. To assist in cleaning the water, a secondary wet well was installed in the pond.

*Shoreacres' secondary wet well.*

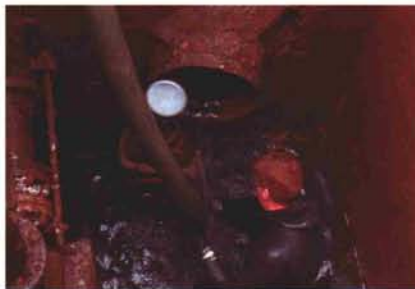
pressure maintenance pump and two 60-hp pumps are able to provide 1,200 gpm. The water source is a pond fed by two wells. Upon inspection, we found very little silt in the flume and none within the wet well, so water quality was very high, eliminating the need for additional filtering systems.

*Cleaning out the wet well at CGC.*

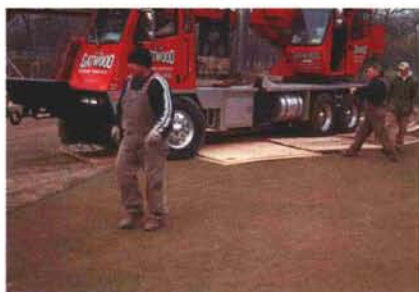
Crane on no. 18 at Shoreacres.

A flagged pathway was set in the rough for trucks to follow, creating a haul road to the construction site. The road area incurred very little damage; most of it could be repaired with a roller. The exception was at the area surrounding the pump house, where most of the turning occurred with equipment. Plywood came into use in some areas when necessary; for example, a crane sitting on no. 18 tee lifted the pumps off the truck down a ravine and into the building.

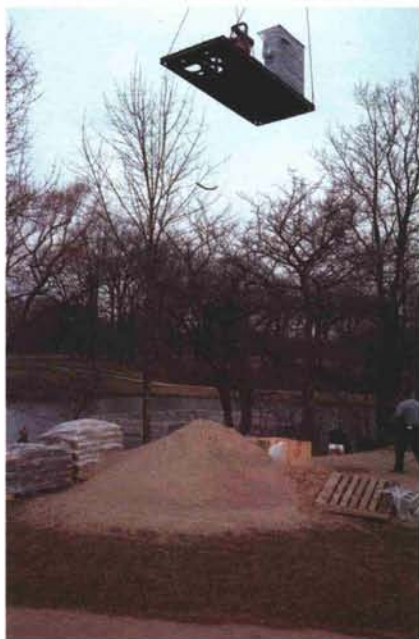
Lifting pump station into pump building at Shoreacres.

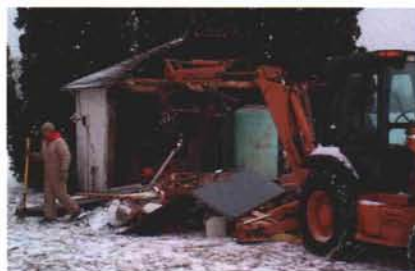
Demolition of old pump station at CGC.

The building permit came through on Friday, February 22, and we contacted ComEd to remove the old electric meter from the building. Demolition of the old building commenced on Monday, February 25, with the disconnection of the electrical service, removal of the electrical meter and dismantling of the electrical panels within the building.

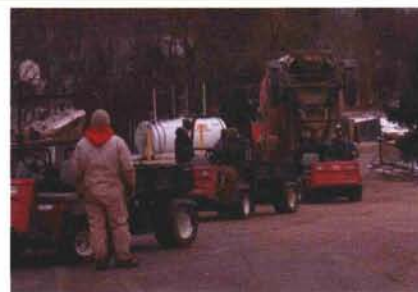
Utility vehicles used to transport cement at CGC.

On Tuesday, February 26, tear-down of the building began. Footings for the new building were poured on Thursday, February 28. At this point, the ground had become soft. We set plywood across the fairways and utility vehicles were used to transport the cement for the footings from the trucks.

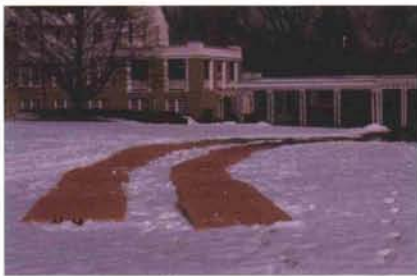
*Plywood path for cement trucks to traverse to minimize golf course damage.*

The real fun began two days later. The forms for the foundation were dismantled and it was time to pour the floor. The temperature the day before had reached 50 degrees, so the snow was beginning to melt rapidly. The forecast called for warmer temperatures coupled with rain during the next seven days. In order to move the requisite amount of cement to the construction site, a large truck would need to get across the golf course, as it would take too long using utility vehicles. We purchased 100 sheets of 5/8" plywood to move the cement trucks. When it was time to pour the floor early that afternoon, the temperature was already in the lower 50s with the sun shining. The first cement truck arrived at 1:30 p.m. We double-sheeted the plywood and set it up for the cement truck to travel upon. We opted for a direct path leading from the clubhouse to the construction site.

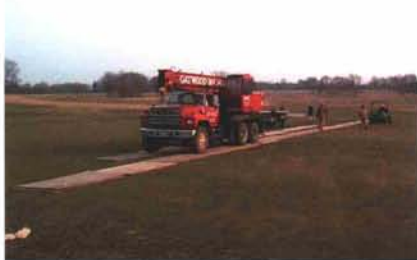
*Truck traveling across plywood at CGC.*

When the truck had traveled 200 feet, reaching the end of the plywood, we would go back and move the wood forward for the truck to travel another 200 feet. We performed this process eight times in order to reach the area; the trip included crossing the no. 18 and no.

1 fairways and the driving-range tee. The gross weight of the truck full of cement was 79,000 pounds. The result of our diligence was evident when the truck reached the pump-house area and exited the plywood to turn into position. The wheels immediately sank 8" into the turf. The truck made all of its turns within a designated area of disturbance surrounding the pump house. After emptying the concrete, the truck was much lighter, making the return trip easier. We used single sheets of plywood in the rough and double-sheeted the driving-range tee and fairway crossings. The remaining section of the floor necessitated bringing out only a small amount of concrete. Again, we used utility vehicles. When all of the cement had been transferred from the truck to the pump house, the sun was setting and the temperature was dropping. The floor was completed at 8:30 p.m. using the lights of a skid steer and a pickup truck. The forms came off the foundation walls on Monday, March 11 and the concrete block walls started to go up Tuesday, March 12.

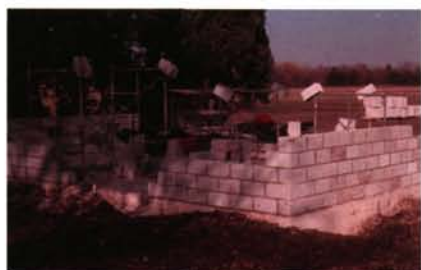
Erecting building at CGC.

The walls are constructed 8' high and the new building measures 24' x 24' for a total of 576 square feet. The east and west sides of the building offer double doors for access. A section of the floor is recessed to accommodate a fertigation system in the future. This area

measures 9' wide, 22'9" long and is 24" below the primary floor and surface of the wet well. A sump hole sits in the corner of the floor to collect any water from the station or spillage from the future fertigation system.

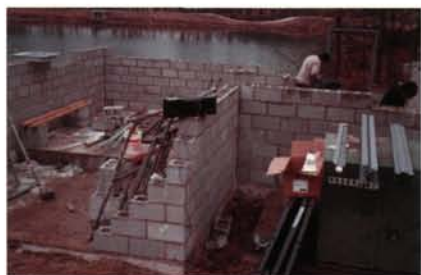
Shoreacres' building goes up around existing transformer.

The building at Shoreacres, meanwhile, is very elaborate. Measuring 24' x 24' less an 8-1/2' x 8-1/2' section to accommodate the electrical transformer, the total area for the building is 504 square feet. The cost and difficulty of relocating the transformer called for the building to surround the existing transformer.

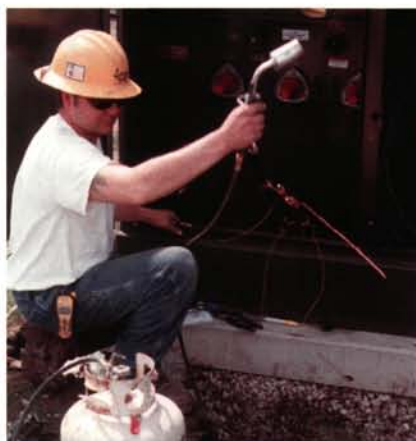
Working on the transformer at CGC.

Set a strict timeframe for your contractor. Pumps are critical and with the unpredictability of the weather, it can get hot quickly in the spring, resulting in a need for water for existing turf or sod. If a transformer is being installed, it can still be three days to three weeks before it is energized. If you have a shallow water source, do whatever possible to prevent contaminating debris from entering the pumps, as well as secondary wet wells and strainers; this will prolong their life. Do whatever possible to avoid equipment damage to the golf course. These areas will become very unsightly and take longer to recover than you anticipate. Have a power contingency. Find out about generators to run the pump system in case the utility company is unable to energize the pump station on time. Be sure you know exactly who owns the primary power cables into your prop-

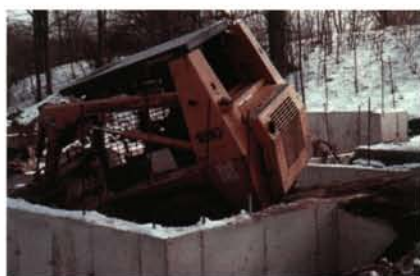
*Even with the best planning, "things will go wrong," as this episode at Shoreacres testifies.*

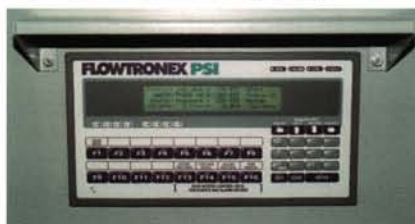
*Data control pad for pump station.*

The same results have been evident at Chicago Golf Club. Integrated with pipe looping and nozzle change-outs, the coverage and performance of the irrigation system is much improved. The new pumps run very smoothly. The building offers an abundance of light and space, making work and access very easy. Evaluating the status of the system and diagnosing problems is very straightforward. Touch-screens provide an array of information to correct even the most complicated issues.

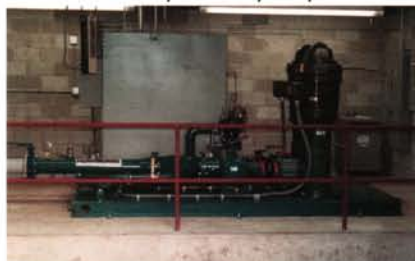
*Inside of new pump station at CGC.*

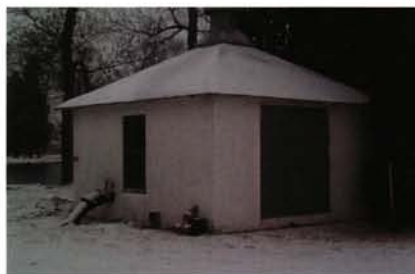
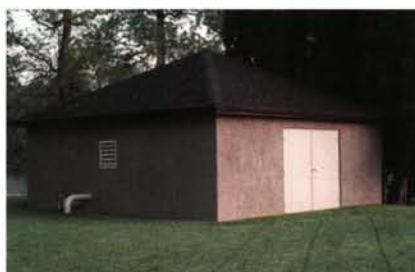
*Chicago Golf Club's pump house: before and after.*
