# Hammering away at a maintenance nightmare

## Burning Tree CC staff solves drainage problem

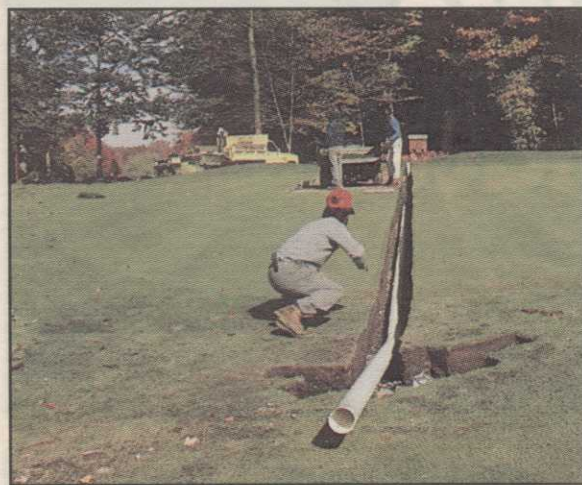
Workers at Burning Tree CC install PVC pipe to solve a drainage problem on the 15th green. They first had to drill through the putting surface and underlying ledge with a jackhammer. Superintendent Steve Renzetti reports the 15th is now one of the top greens on the Greenwich, Conn., layout.

Knowing the granite-like rock would not chip easily, the three-man crew settled into what they knew would be a lengthy job. They took turns hammering the stone. Two days and many tired muscles later, they broke through.

A slow trickle of water passed through the trench they created down the green's center. We laid 4-inch perforated PVC drainage pipe back-filled with pea gravel. That was covered with filter fabric overlaid with 10 inches of top mix.

Even though the rest of the green was formed from native soil, we went with a 80-15-5 topdress mix over the reconstructed area to maximize water percolation into the drain tile.
