Dealing with donuts

Nearly exhausting his options to **combat donuts**, one superintendent swapped out irrigation heads to **improve distribution** uniformity on his golf course.

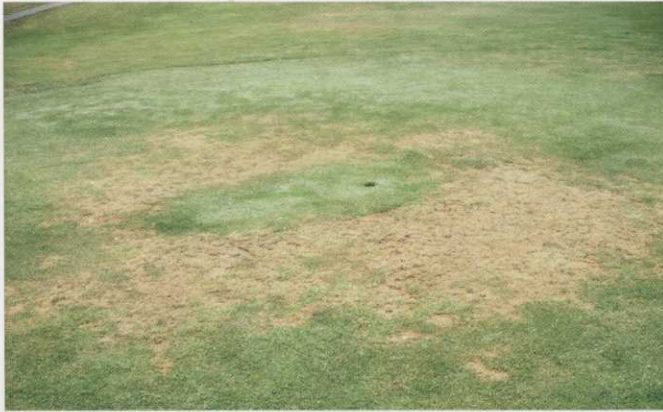
Top: Donut damage. Superintendent Dennis Eichner says you can place your hand over the stainless steel nozzle's spray pattern and see the uniform coverage.

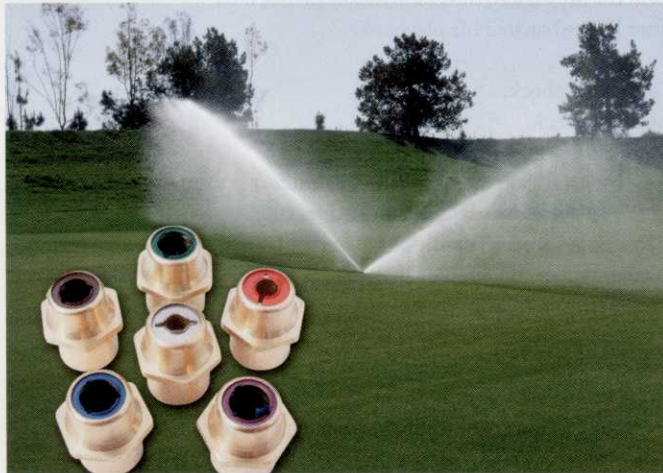
The set arrived, the crew switched out a couple heads and waited skeptically. Within a week, Eichner's test turned out to be a win-win-win for the course, the players and the crew. "The donuts disappeared and the improvements were visible to everyone," he says. "You could actually place your hand over the spray pattern and see the uniform coverage. It's like a fine, gentle rain."
