## Travels With Terry

### HOMEMADE LEAF VACUUM

## SCUBA AIR TANK

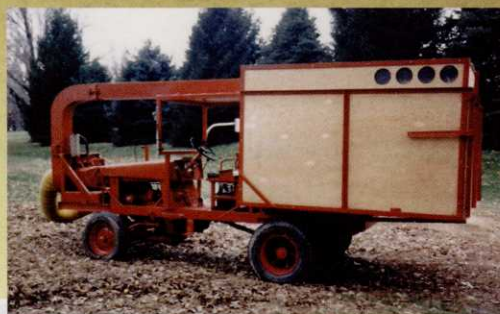
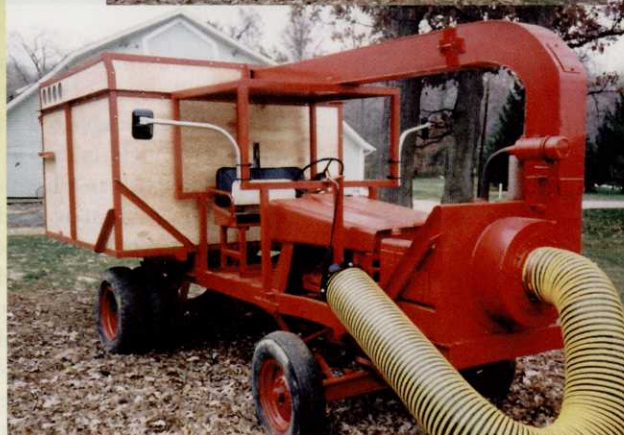
This 1950s vintage Toro general tractor (gasoline engine) was transformed into a vacuum/blower used primarily for leaf cleanup around the clubhouse at The Manor Country Club in Rockville, Md., where Randall Pinckney is the superintendent and Richard Bassett has been the equipment manager for the past 26 years. Bassett used a gasoline-powered, low-blow blower/vacuum with a 12-inch-diameter suction hose mounted in front of the radiator after the frame was extended. The HVAC heavy-duty ductwork was extended from the blower to a plywood box. The 3/4-inch-plywood box measures approximately 8 feet by 10 feet with a metal mechanical tailgate made from tubular steel and flat steel. It has four 9-inch-diameter holes with screens on either side to release the volume of air from the vacuum. It took about 10 days to build and most of the parts were in inventory.

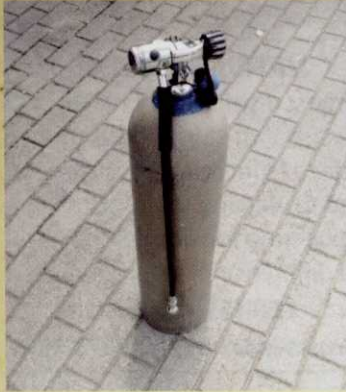
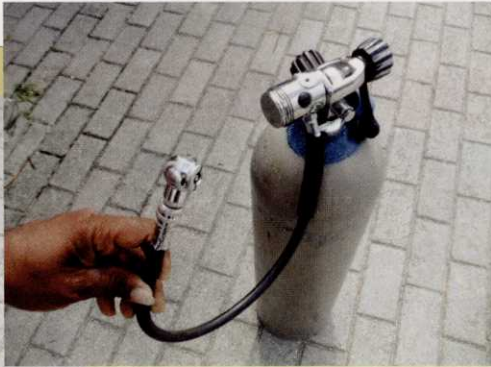
Grand Cayman in the Cayman Islands, British West Indies, has a strong scuba diver presence. The North Sound Club, the only 18-hole course on the island, repurposed a used scuba diver tank. A high-pressure flexible air hose and air chuck made it into an easily transported air tank, used to pump up the tires on the 40 E-Z-GO golf carts in their fleet. The used scuba tank holds from 2,700 to 3,000 PSI, and costs about \$4 to fill up completely with oxygen at a local specialty scuba shop. A regular air tank holds much less air at a lower pressure – which would run out quickly with use. With regular use for the carts, it would usually need to be refilled every 2 weeks. Though the tank is moderately heavy, it can be moved easily enough by one crew member to fill cart tires by hand. Two valves are installed on the tank, with one controlling the on/off operation and the other regulating the flow of air. The high-pressure flexible air hose and air chuck were acquired at a local auto parts store and installed by the crew. Jason Deerwester, director of golf, Robert “Chilly” Chilman, associate golf professional, Anthony Persaud, acting superintendent, and Davy Eubanks, general manager are the team members behind the repurposed tank. The used air tank cost the club about \$150, the air hose/air chuck cost about \$45 and it took about 15 minutes of labor to install the air hose. GCI
