# Travels With Terry

Globetrotting consulting agronomist Terry Buchen visits many golf courses annually with his digital camera in hand. He shares helpful ideas relating to maintenance equipment from the golf course superintendents he visits – as well as a few ideas of his own – with timely photos and captions that explore the changing world of golf course management.

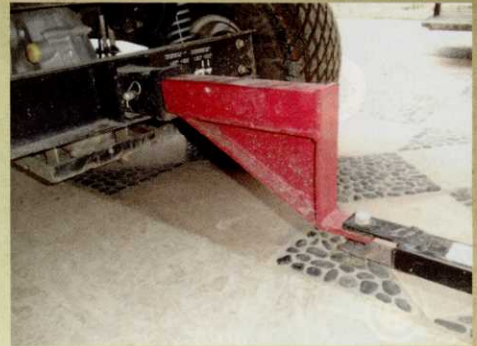
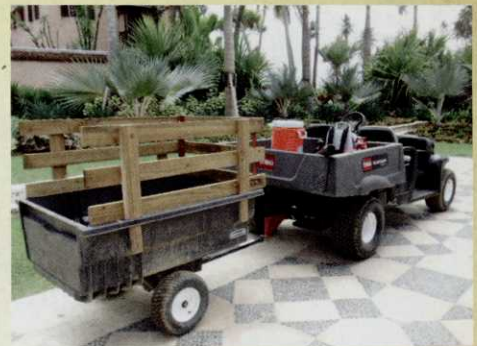
## TOW VEHICLE HITCH

The 2012 Model 07273 Toro Workman MDX turf vehicle came equipped with a factory-mounted Category III Reese-type receiver without a hitch. An in-house hitch was built which extends outward approximately 16 inches and drops down 4 inches to keep the trailer level using 2 inch x 2 inch x ¼ inch square tubing that slides into the receiver. The remaining fabricated flat steel pieces are also ¼ inch thick. A ½-inch diameter hole was drilled into the hitch so that a lynch pin could slide in to hold the hitch in place. The hitches were welded together and then painted with a primer and a “Toro red” spray enamel. The Rubbermaid Model 6WU47 Trailer (15 cubic yard) navigates short curves easily, does not “jackknife” or hit the tailgate in any way because the hitch is far enough away from the tow vehicle. The cost for each hitch was less than \$30 after the R&D was completed and it took no more than 2 hours to build and paint each one. Brad Boyd, director of agronomy, Manuel Benitez, equipment manager, and Eliud Cruz, mechanic/fabricator, make up the team at the Dorado Beach Resort & Club in Dorado, Puerto Rico.

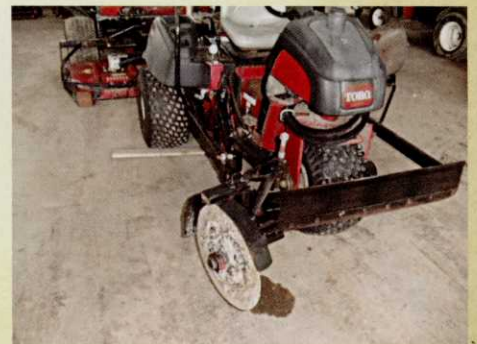
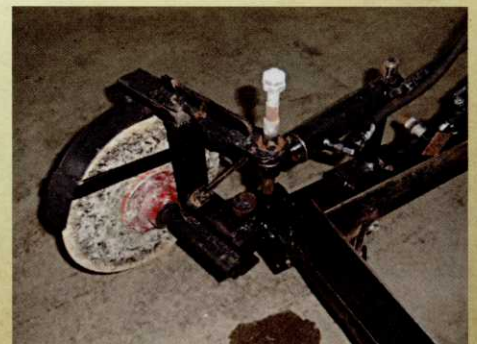
## CART PATH EDGER

The Dorado Beach Resort & Club in Dorado, Puerto Rico, has a 2005 Toro Sand Pro that has a modified cart path edging wheel. Two maintenance staff used to take about four days to edge the cart paths on 72 holes with trimmers, where it now takes one person 1½ days. The edging wheel blade can be raised, lowered & angled hydraulically, by using the lift handle that used to operate the rear rake mechanism, so that the proper position is achieved, especially when going around curves on the cart paths. Many of the hydraulic components were “cannibalized” from retired triplex mowers and the hoses & fittings are new that cost about \$50. The R&D took about three weeks after many field trials for proper refinement. For example, the front length of the Sand Pro had to be reduced because of the variable turning radius of the machine vs. the cutting wheel itself. The engine was also rebuilt in-house. The total labor cost about \$400. Brad Boyd is the director of agronomy; Eliud Cruz is the fabricator; and Manuel Benitez is the fleet manager. **GCI**
