SYSTEM SHAKE UP

Now is the time to make those improvements to your irrigation system. by Rob Thomas

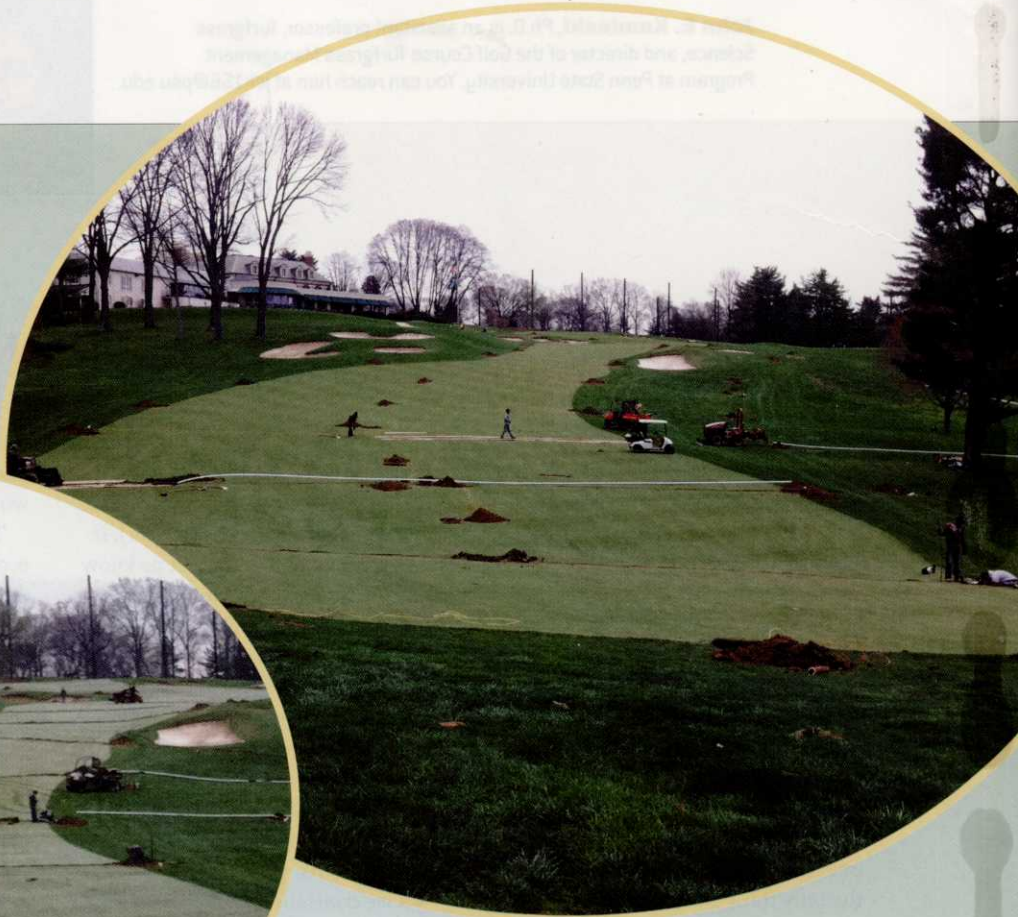
Crews install the replacement irrigation system on the 18th fairway at Overbrook Golf Club.

The irrigation system at Overbrook Golf Club in Villanova, Pa., was not considered old (16 years), but was outdated and beginning to break down, according to superintendent Tom Gosselin.

To address its issues, Overbrook installed a Toro system equipped with Lynx software.

The new system is five rows through the fairways, ins and outs on the greens and has very good coverage in the rough.

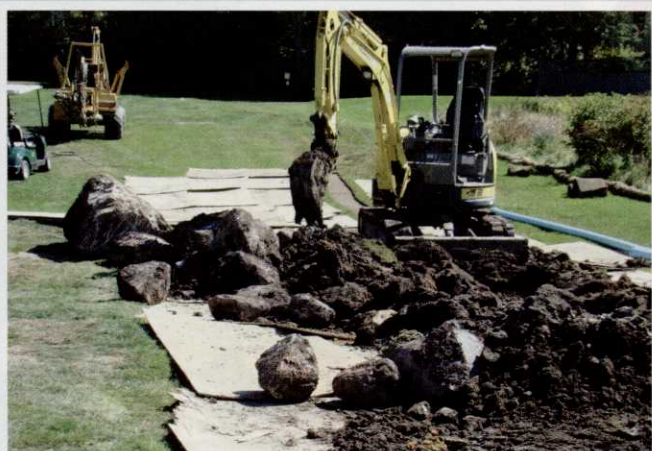
ESSEX COUNTRY CLUB

Essex Country Club was spending more than \$20,000 annually to keep the irrigation system partially operational, says Richardson.

Entering his sixth season at Essex County Club, Richardson inherited a traditional single-row irrigation system with impact heads. It was the first automated system the club had ever installed.

have, from faulty grounding, to a lack of pressure, poor pipe sizing, faulty pumps, faulty fittings (mostly galvanized), stuck heads, lack of coverage, etc.," he says. "The club was spending \$20,000 annually just to keep the system semi-operational.

A triple-row system – with part circles on the perimeter and full circle heads down the middle – now graces the fairways. The part circles are used to water some of, but not all, the mowed rough, providing a sporadic pattern allowing the farther edges to fade out into the tall rough.
