## Travels With **Terry**

Globetrotting
consulting agronomist
Terry Buchen visits
many golf courses
annually with his digital
camera in hand. He
will share helpful ideas
relating to maintenance
equipment from the golf
course superintendents
he visits – as well as
a few ideas of his own
— with timely photos
and captions that
explore the changing
world of golf course
management.

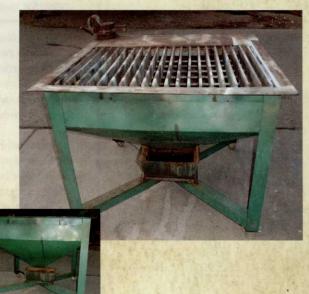
## **WELDING TABLE:**

The top portion was formerly a storm drainage grate with ½-inch steel slats spaced approximately 1.5 inches apart.

The legs, support frame and top edge around the grate are 3-inch angle iron with ¼-inch flat steel – all welded in place – with a 4-inch vice bolted on.

Two-inch caster wheels are welded onto each leg for portability. There is a removal "catch pan" placed over the intersection of the support frame that is filled with water to cool the slag from the welding operation as a safety measure, which is held in place with 1-inch angle iron. The materials were either purchased or were recycled and the total cost was less than \$200.
