Travels With Terry

MECHANIC'S STAINLESS-STEEL SHOP TABLE

EQUIPMENT LIFT TABLE

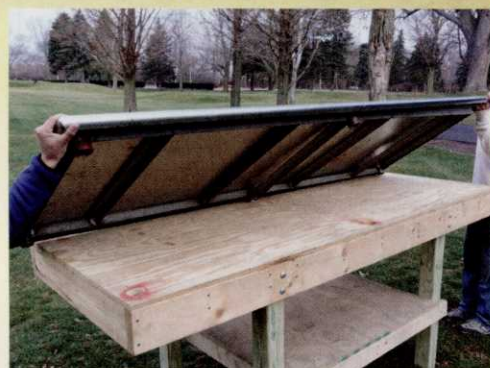
The Kenosha (Wis.) Country Club remodeled their clubhouse kitchen and they were given a discarded stainless steel table, which was recycled by Scott Verdun, golf course superintendent, Nate Keller, former assistant superintendent, and Dann Steltenpohl, mechanic, and transformed into a mechanic's stainless-steel shop table. The legs were cut-off of the 8-by-3-foot stainless-steel table top and the new wooden frame below was built using 7-foot-10-inch-long and 2-foot-by-10-inch-wide dimensions. The main wooden frame is made of 2-by-6-inch construction pine with 2-by-4 boards for additional support every 10.5 inches. The frame is held together using 16d 3/2-inch nails. 4-by-4 posts makeup the table legs, which are anchored to the main frame using 7-inch lag bolts. An additional shelf was made 18 inches above the floor, supported by a 2-by-4-inch frame covered with 3/4-inch plywood, which is commonly used for tools and parts storage. The top of the wooden frame was covered with 3-by-4-inch plywood with two 1-by-4-inch holes drilled in all four corners to slide the original table leg supports into. With all its sturdiness, this table can easily support the weight of two walk-behind greens mowers in addition to a 210-pound superintendent, who tested the stability and safety. This table is quite heavy and sturdy, which does not require it to be bolted to the floor, so it can be moved whenever necessary. The total material costs were approximately \$80 and it took about 1 1/2 hours to build.

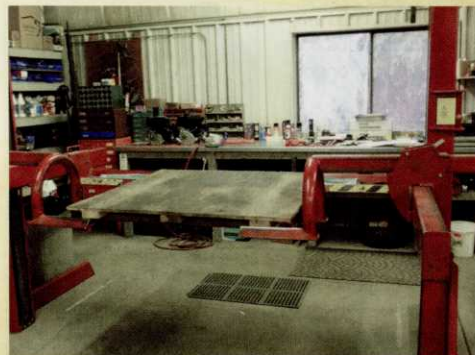
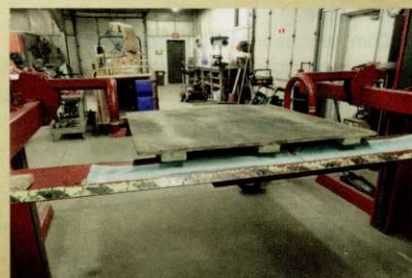
The 4-foot-by- 4-inch wooden lift table is placed on the lift arms on the Trion Equipment Lift, which is held in place by gravity and it can be easily removed as required. It is used primarily to elevate the walk-behind green's mowers and small equipment for daily service and preventative maintenance. The table top is made of 3/4-inch plywood. The bottom of the table is supported by three 44-inch 2-by-4 beams screwed to the plywood and three additional 44-long inch 2-by-4 beams at 90 degrees for additional support and stability on the lift. All screws on the surface were countersunk so moving equipment around would not catch on the screws. The front rollers of the walk-behind mowers are placed on the platform then the handle is lifted to place the rear roller and transport wheels onto the table in lieu of using ramps. All of the materials were already in stock. If they were purchased the project would have cost approximately \$35. Total labor time was about one hour. Scott Verdun, superintendent, former assistant superintendent Mike Kudrna, and mechanic Dann Steltenpohl are the innovators at the Kenosha (Wis.) Country Club.
