Travels With Terry

Globetrotting consulting agronomist Terry Buchen visits many golf courses annually with his digital camera in hand. He shares helpful ideas relating to maintenance equipment from the golf course superintendents he visits – as well as a few ideas of his own – with timely photos and captions that explore the changing world of golf course management.

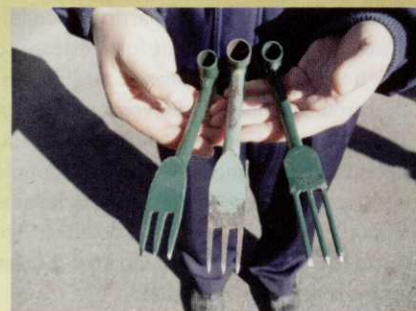
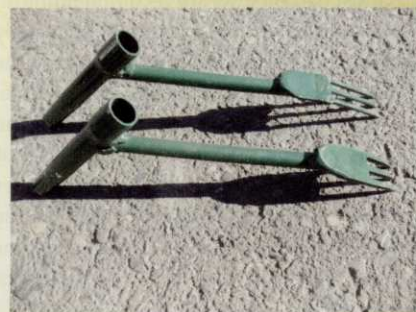
BALL MARK REPAIR TOOLS

The fork on the right was made using used flat steel as the base and $\frac{5}{32}$ -inch diameter concrete nails welded in place. The other two forks were made using used greens mower bed knives with the forks cut out with a metal jigsaw. The Narrow's aerifier tines are $\frac{25}{64}$ -inch and $\frac{5}{8}$ -inch diameter, respectively, and are welded to the forks with $\frac{1}{4}$ -inch diameter rounded steel. Two coats of water-soluble acrylic resin coating spray is then applied. These ball-mark tools are placed on the back of the walk-behind greens mower handle and the ball marks are repaired daily prior to mowing. All of the materials were recycled parts in inventory and it took about 30 minutes to make each one. Masaru Shimizu, manager, (chief greenskeeper), at the C.J.P. Kasumigaseki Country Club in Saitama Prefecture, Japan, conceived this great idea. Shimizu's 36-hole club, founded in 1929, is in the planning stages to host the golf competitions for the 2020 Olympics, where Tokyo is a candidate city. The club has previously hosted the Japan Open in 1933, 1956, 1995 and 2006; The World Cup in 1957; the Japan Women's Open in 1999 and the Asian Amateur Championship in 2010.

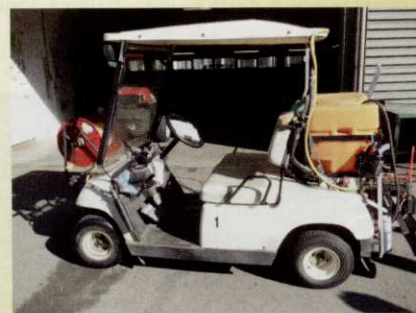
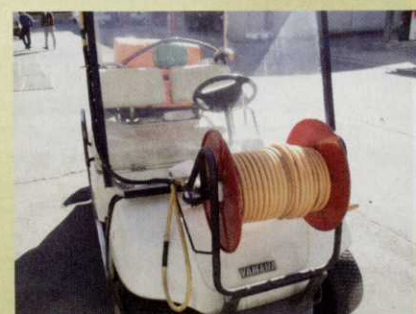
GOLF CART SPRAYER

This 2001 Yamaha gas-engined golf cart was transformed into a versatile sprayer used for miscellaneous spot spraying of the club property. The rear bumper was extended outwards using 2-inch angle iron and 2-inch square tubing that was also used to make the metal floor. The golf bag rack was removed and a 26-gallon fiberglass tank was mounted with a 2-inch angle-iron frame. A 4.3-hp Kubota gasoline engine powered sprayer (up to 217 psi) was mounted on the rear flooring. A self-contained manually operated hose reel and frame manufactured by Maruyama holding approximately 164 feet of $\frac{21}{64}$ -inch diameter high-pressure hose was bolted/welded to the bumper frame and windshield mounting. The high-pressure hose from the sprayer to the hose reel is attached with zip strips along the roof frame. A portable marking paint gun is mounted on the rear and safety equipment is easily stored in the front compartments. The parts cost about \$1,000 and it took about 16 hours to complete the project. Masaru Shimizu, Manager, (chief greenskeeper), at the C.J.P. Kasumigaseki Country Club in Saitama Prefecture, Japan, conceived this great idea.
