WHAT WERE THEY THINKING?

Getting to the bottom of a unique installation.

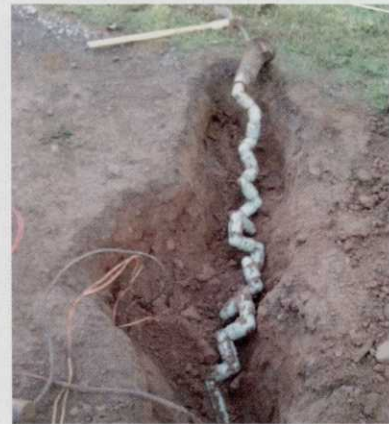
I was sent the picture to the right and after my “Oh my God!” reaction, I figured a review of its hydraulics is in order. First, a few comments on the picture:

- Obviously there was no pipe on the truck or in the parts room, but there were lots of swing joints;
- The course has a high budget as swing joints are more expensive than pipe;
- Pressure is high as friction loss is not a concern; and
- Whoever installed the sprinkler had lots of time on their hands to complete the work and thread all the swing joints together.

Designers are concerned with two things, friction loss and velocity. The sprinkler is most likely a 1-1/2 inch inlet, so all the swing joints can be assumed to be 1-1/2 inches, too. The average flow on a 1-1/2 inch golf sprinkler at 80 psi is about 38 gpm. We don't know the inside diameter of a swing joint, but we will go with 1.5 inches, which is being generous. Doing the math, the velocity through the swing joint would be 6.9 feet per second (fps). Velocities in PVC pipe are supposed to be limited to 5 fps, but a 1-1/2 inch sprinkler on a single swing joint is common at that velocity on most course irrigation systems. It is also for an 18-inch swing joint. This swing joint is somewhat longer – hard to say but looks like 6 to 7 feet at a minimum in a straight line, not including the elbows. The higher velocity at the longer length as well as the turns will make the water very turbulent and add to the water hammer potential when it's turned on and off.

The friction loss in a 1-1/2 inch, Class 315 pipe at 38 gpm is 3.67 psi per 100 feet. So at 7 feet that would be a friction loss of only 0.26 psi. That's not very much, but that assumes there are no turns. The Rain Bird website – it's a Rain Bird sprinkler and the color makes me think Rain Bird swing joints – says about 0.5 psi friction loss through their 1-1/2-inch swing joint. A normal swing joint has three turns; this one looks to have 25 turns, just a few more than necessary. So the friction loss through this mess is at least 4 psi, but given the configuration I am sure it is more like 10 to 15 psi.

When they calculate system hydraulics, most designers do their analysis through the mainline pipe and maybe the lateral piping. They would use a number of 1 or 2 psi for the swing-joint friction loss. So for a sprinkler operating at 80 psi they might assume a minimum pressure of 82 or 83 psi at the sprinkler base or because valve-in-head sprinklers are pressure-regulating more likely 92 or 93 psi. Remember, valve-in-head sprinklers require a minimum 10 psi difference in pressure for the sprinkler to regulate. In this case, with the excessive friction losses, the sprinkler is most likely not receiving the intended pressure and it may not be receiving the intended flow.

So let's look at the installation aspects of this configuration. My first question is – why? What would make someone think of doing this let alone do it? Followed by; who is supervising the work? On golf course irrigation systems hydraulics are extremely important and their analysis quite detailed. The person who installed this elongated swing joint either had no idea how it would affect the sprinklers' operation or didn't care. It may have been done to get the sprinkler out from under a cart path, but that's no excuse.

Sprinklers are sensitive to pressure issues which affect both the distance of throw and the flow and therefore the uniformity. It's important staff and installer crews are educated on how their actions can affect the operation of the overall irrigation system and the individual sprinklers.
