Travels With Terry

Globetrotting consulting agronomist Terry Buchen visits many golf courses annually with his digital camera in hand. He shares helpful ideas relating to maintenance equipment from the golf course superintendents he visits – as well as a few ideas of his own – with timely photos and captions that explore the changing world of golf course management.

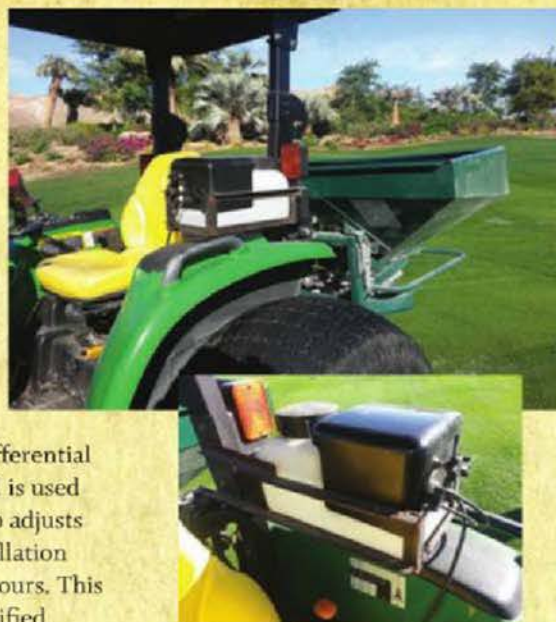
FOAM MARKER

This 2010 John Deere Model 4520 Tractor with a 2010 Lely Model L2010 fertilizer spreader has a Richway Industries Model TF2020SD foam marker that is used when fertilizing fairways and roughs. The holding box was built using a $\frac{3}{4}$ -inch by $\frac{1}{8}$ -inch thick angle iron welded together that then is mounted to the ROPS using existing bolts. The electric harness, included with the foam marker, was wired to an on/off switch on the tractor's right side control panel. The $\frac{1}{2}$ -inch-diameter discharge hose has a special "collector head" nozzle for foam disbursement that is placed next to the tractor's differential approximately 8-12 inches above the ground. Foam Trail is used at 2-4 ounces per gallon of water where the control knob adjusts the foam discharge rate as desired. The cost for the installation materials was about \$7 and the labor time was about 2 hours. This very exclusive private golf club requested to not be identified.

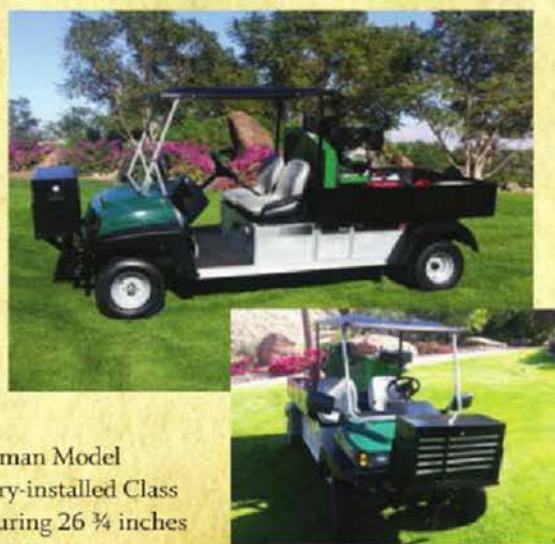
MECHANIC'S SERVICE VEHICLE

This 2008 Club Car Carryall 295 started out life as a beverage cart. The cargo box was built in-house using 16-gauge sheet metal and 14-gauge diamond plate on the bottom with a 1-inch-by-1-inch by $\frac{1}{16}$ -inch square tubing frame. Spare tires, fuel cans, shop rags, tire-repair kits, straps, cutting tools are some of the items carried in the box. The materials, including the paint and bed coating, cost about \$400. The 2010 John Deere Model AC2-CG35H-P Compressorator combination unit has a 3500/2300 watt generator that also powers a 15.4 cfm @ 175 PSI air compressor with a $\frac{3}{8}$ -inch diameter, 25-foot air hose mounted on a retractable hose reel. Mounting used rubber mounts and $\frac{5}{16}$ -inch-by-3-inch bolts and lock nuts. The 2011 Craftsman Model C931018 tool box was mounted to the front-mounted factory-installed Class III 2-inch receiver hitch with a mounting frame built measuring 26 $\frac{3}{4}$ inches by 12 $\frac{3}{4}$ inches by 11 inches made with 1 $\frac{3}{4}$ -inch angle iron and supported by 2-inch-by-2-inch square tubing with side reinforcements made of 1-inch-by-1-inch square tubing inserted and bolted together. The materials cost about \$70. The two large Balkamp Model BK827459 side rear view mirrors, and mounting hardware, were installed by drilling holes in the front cowl per manufacturer's directions. They cost about \$35 each. About 16 labor hours were required. This very exclusive private golf club requested to not be identified.
