Houston Ends Flood Ravages

The Houston Country club, one of the deluxe southern layouts, has triumphed over a poorly drained section by engineering work that gives every assurance of permanently eliminating the flood peril.

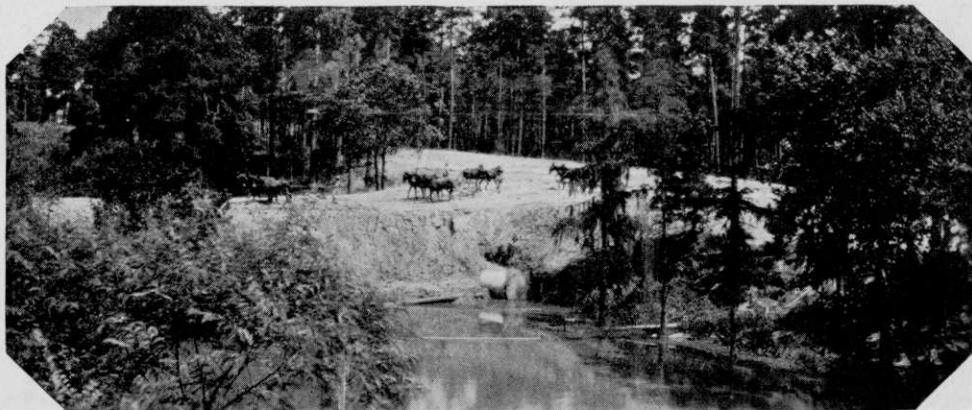
Houston's Big Culvert Is Seen Coming Out Under the Levee Into the Bayou

structing a levee along the bank of Brays Bayou adjacent to the Country Club, between high points, a total distance of approximately 1,100 feet. The levee was designed by R. G. Hamaker, chief engineer of the Humble Oil Company. The amount of earth embankment in the levee is 10,000 cubic yards. The crown is 10 feet in width, with slopes $1\frac{1}{2}$ to 1. The greatest height of the levee is 22 feet.

The levee crosses Slaughter Pen Bayou at right angles, which necessitated a culvert structure through the levee to drain this bayou. A 72-inch diameter No. 10 gauge Armco corrugated culvert was selected. Attached to this pipe is a Calco automatic drainage gate, which operates as a valve and permits the water to run out from Slaughter Pen Bayou before the Brays Bayou water rises perceptibly. When the water level in Brays Bayou reaches an elevation greater than the water level in Slaughter Pen Bayou the gate closes automatically, preventing backflow into the bayou and eliminating the overflow.

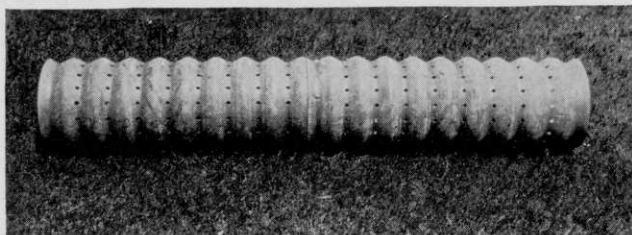
This long-lived iron drainage pipe is making itself popular in course construction.
