Drainage Eliminates Uninvited Los Angeles Hazard

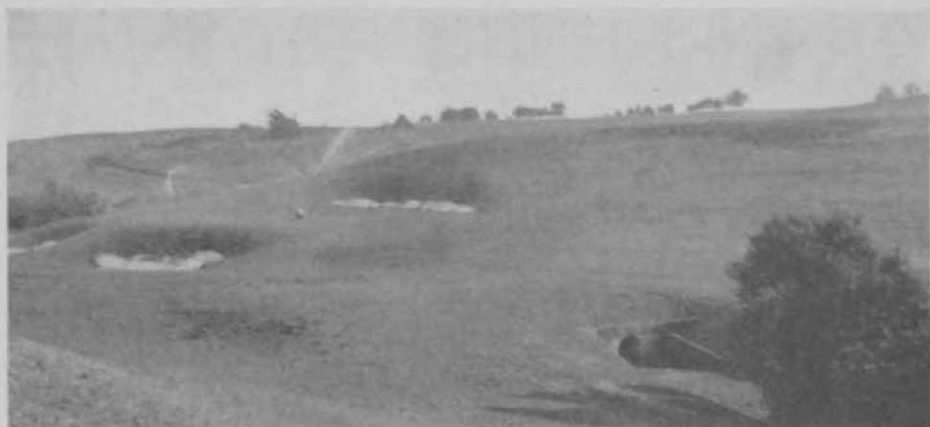
Restored green on the Los Angeles Country Club course after installation of new storm drain.

On the widely known "north course" of the Los Angeles C. C. the overflow of storm water caused a ravine which broke the sloping contour of the new sixth green.

A remedy for this condition called for a storm drain that would remove the excess water which caused the overflow with its accompanying damage. The situation also made it necessary to speed up the installation of this drain before additional damage was done.

In this case an effective, quickly placed remedy was found in the installation of 240 feet of 42-inch Armco corrugated iron pipe. Included in this length of pipe were two 45-degree elbows required by the changing direction of the flow line. A fill was then made until the slope of the ground over the pipe was continuous with that of the rest of the green.
