## Merion's New Water Plant Is Golf Club Jewel

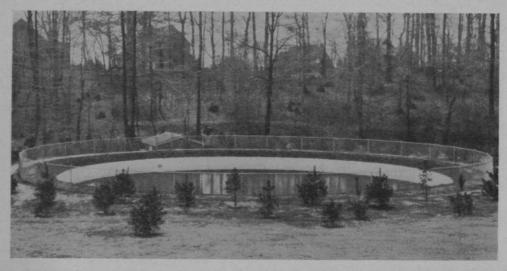
This circular storage reservoir assures the Merion Cricket Club a supply of 300 thousand gallons of water for course needs. It is filled gradually by pumping from adjacent streams.

This reservoir has a capacity of 300,000 gallons, and is of the cut and rolled earthen embankment type, being floored and lined with reinforced concrete. The primary purpose of the reservoir is to balance the supply to the pumps and to avoid the taking at any time of the entire stream flow. For many reasons it was deemed advisable to maintain a natural flow of water in Cobbs creek and the tributary down stream from the diverting dams. From an aesthetic standpoint alone the green committee was of the opinion that this was of considerable importance.

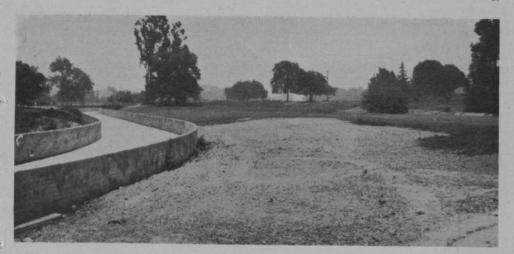
To prevent fairway erosion during the annual rainy season, this concrete flume has been built at the San Gabriel (Cal.) C. C. in the former river-bed. This view was taken during construction of the flume.

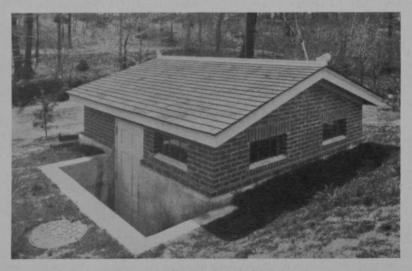
Thoroughly automatic in operation, the equipment in Merion's new pump-house needs no attendant during the hours the course is being sprinkled.

From the reservoir the water flows through pipes by gravity to two centrifugal pumping units in the pump house near by. These are motor driven and they discharge directly into the irrigation lines. One pump has a rated capacity of 100 gallons per minute with a discharge pressure of 115 lbs. per square inch. This unit is operated when it is desired to sprinkle small areas, such as the greens or tees. It is powered with a 15-horsepower motor. The second pump has a rated capacity of 300 gallons per minute with a discharge pressure of 115 lbs. per square inch. This unit is operated when it is desired to

Service tests have demonstrated that the pumping units will support a somewhat greater sprinkler load if occasion demands. In actual service the combined output of both pumps has reached 475 gallons per minute. No attendants are necessary in the pumping station during sprinkling operation as the motors and pumps are fully protected automatically against overload, service stops, etc. The pumps were furnished by the American Well Works Co., motors and switching equipment being furnished by the Westinghouse Electric Co.
