### Gives Cost Data

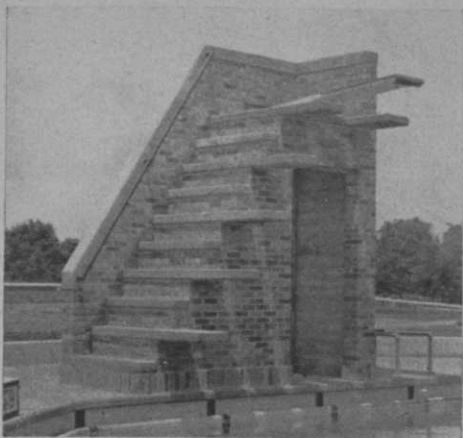
The high dive, with diving elevations at two-foot intervals, is constructed entirely of brick and concrete with the exception of course, of the top springboard. Water is 9 feet deep at this point.
