IRRIGATION SYSTEM MEETS BROOKLINE'S WATER NEED

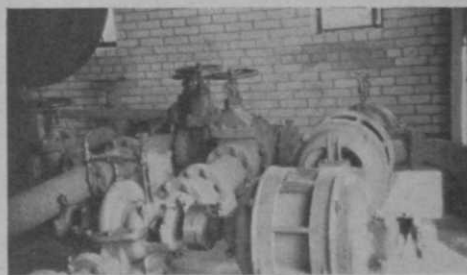
View of main pump-house at the Country Club, Brookline.

The main, or irrigation, pumping station, which is located on the shore of the pond, houses two 500 gal per min centrifugal pumps, driven by 25 hp motors, a smaller pump driven by a 10 hp motor, a 1000 gal pneumatic storage tank built for 150 lb maximum working pressure, a motor driven air compressor and a 4-panel switchboard providing for full automatic operation of all pumps. The small pump and one of the larger centrifugal pumps deliver to the storage tank and the large pump also delivers to the discharge line.
