Rodding Corrects Drainage At Big Saving

By **DON STRAND**

Supt., Westmoreland Golf Club, Wilmette, Ill.

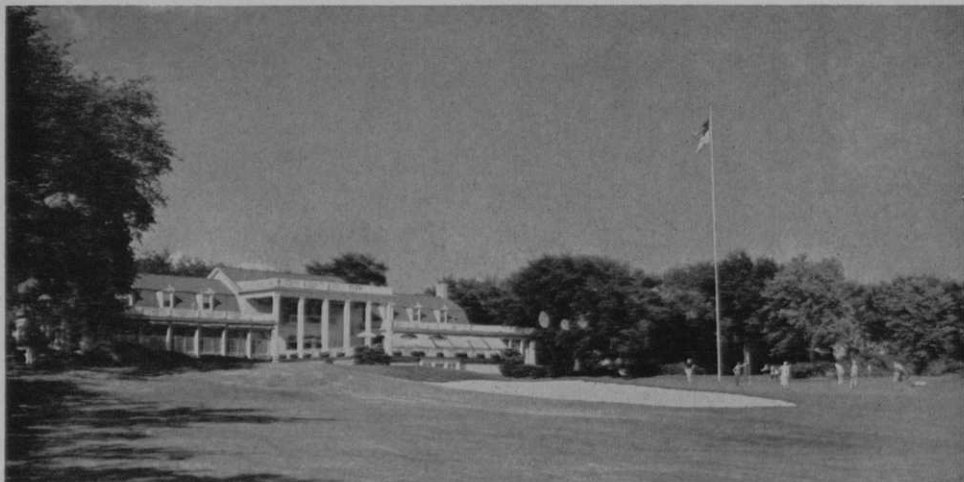
Westmoreland CC (Chicago dist.), as may be suspected from typical wooded view in clubhouse area, had many problems of tree roots clogging drain tiling.
