How to Sell A Maintenance Building

Board Takes Look, Is Convinced and Appropriates Funds

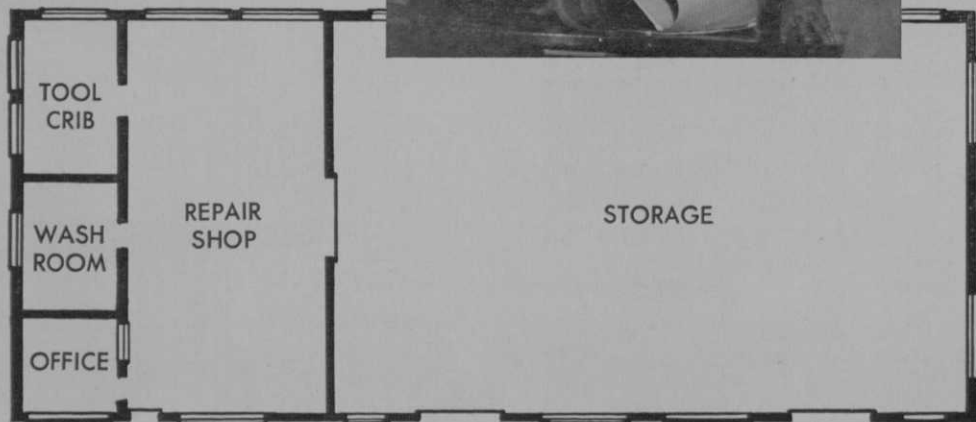
Architect Arnold L. Larsen, Butterfield pres., Larry Faul, and Bert Rost, supt., check the plans for new Butterfield maintenance building which is 120 ft. long, 50 ft. wide.

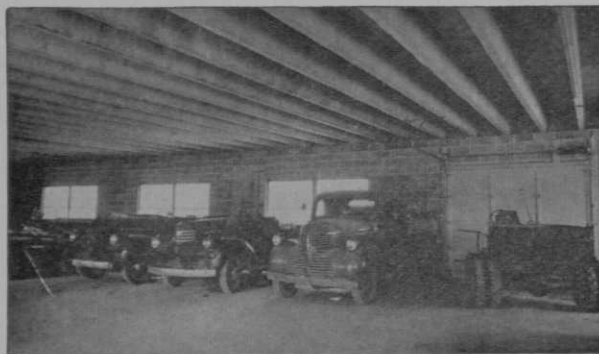
Prestressed roof slabs give column-expanse to permit greater freedom of movement for vehicles within the building at Butterfield CC.

Working within a close budget, Larsen designed a 50- by 120-ft building of utter simplicity that met Butterfield's maintenance needs. Using a concrete floor slab, walls of concrete blocks, and a roof of pre-cast and prestressed concrete, Larsen fulfilled requirements for permanence and economy as well as completely eliminating any maintenance problem.

Another important advantage of the fireproof building was the lower annual fire insurance premiums. By utilizing prestressed concrete roof slabs, a fireproof material carrying a two-hour fire rating from Underwriters' Laboratories, the fixed cost for fire insurance premiums was reduced substantially. Considering that club properties are in a "high hazard" category, remote from fire fighting equipment, this is important.

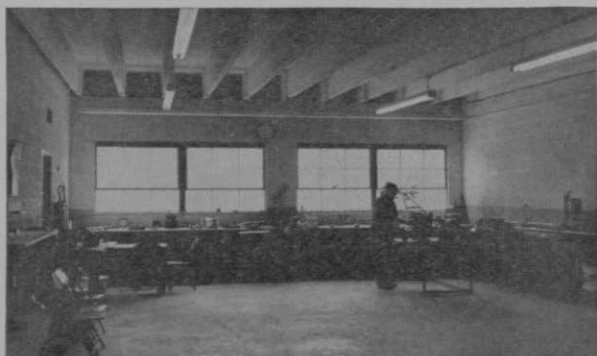
Floor plan of the service center, which includes repair shop, shows extreme flexibility. 50-ft spans of prestressed concrete are fireproof, permit changing of interior partitions to meet future needs.
