*Overcome Formidable  
Construction Barriers*

## **Golfers to Play in Old Pirate Lair on Dauphin Isle**

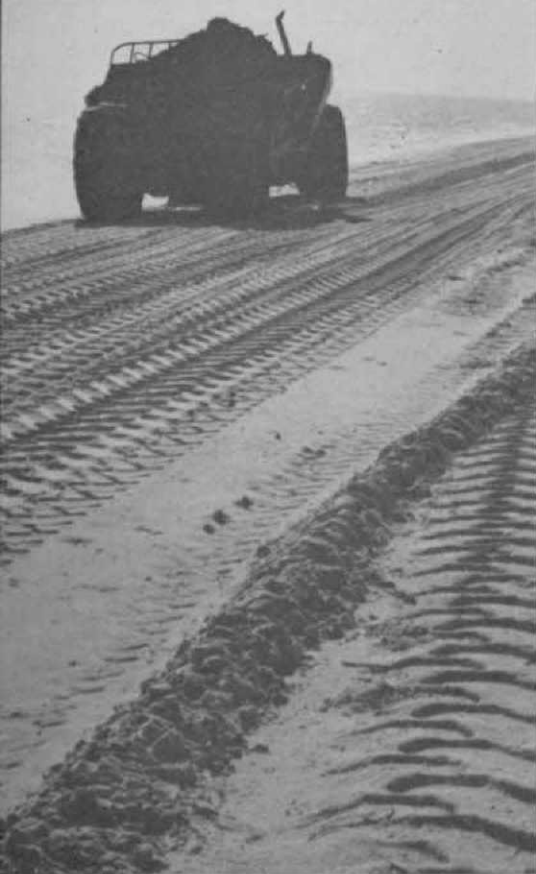
Earth mover hauls tons of silt from Alligator Lake more than one mile to Isle Dauphine course. At high tide machine often ran with one wheel in the Gulf of Mexico.

While many difficulties were overcome in building Isle Dauphine, Maddox says the principal problem consisted of building up the swampy areas for drainage. The hauling of soil from swamp to course site was accomplished by installing a water pipeline along a haul road to the beach. By keeping the sand of the road wet, heavy equipment could travel to the beach where natural wave action kept the surface wet and firm. Crawler tractors, one pulling and one pushing, put topsoil in place on the course where it was rototilled into the top 6 to 8 inches of all

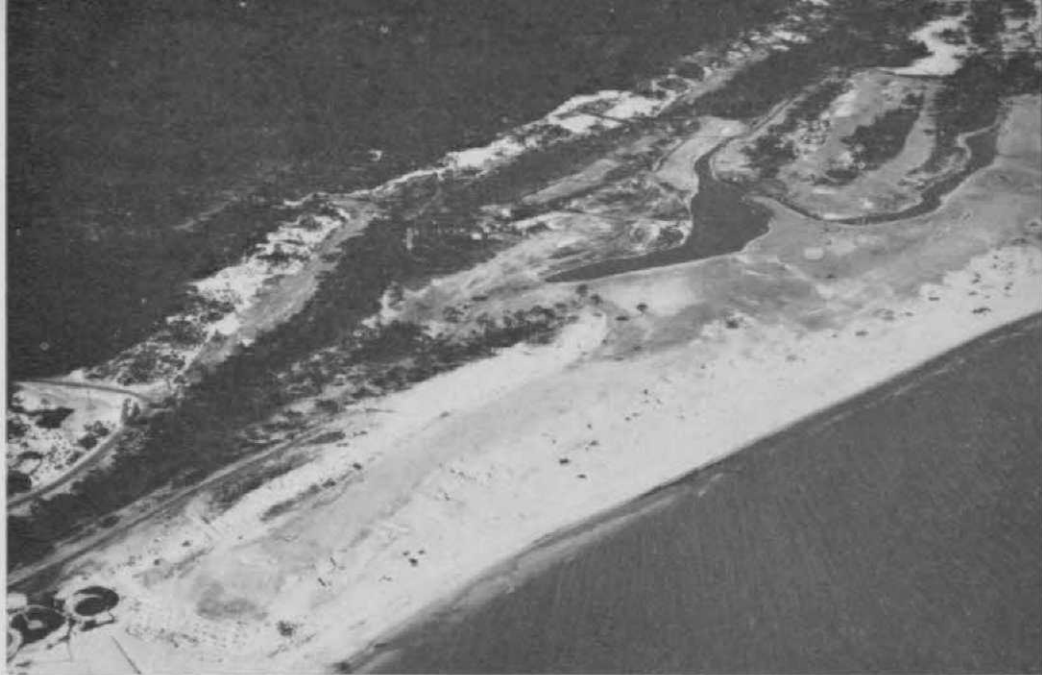
Air view of Dauphine GC. Gulf is in foreground and clubhouse and pool are at extreme left of the photo. Course is watered from the fresh water lake.

Maddox says the biggest asset found on the site was the presence of several small fresh water lakes which his crews enlarged to obtain fill and to make them more effective reservoirs for future irrigation of the course. He is convinced they are spring-fed since, during construction, approximately 1,000 gallons per minute continuously flowed through the overflow line to the Gulf without any appreciable lowering of the lake levels. Fresh water from the lakes was used continuously during construction to leach out the salt in the sand near the Gulf side.

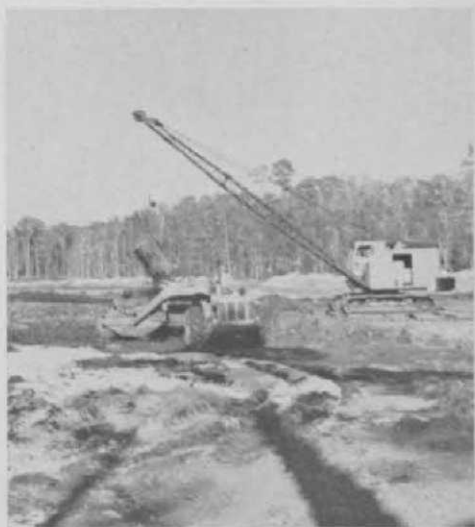
Digging silt from bottom of Alligator Lake to be used as topsoil on the course. Lake was pumped dry by Maddox firm and about 30,000 yards of silt was removed.

any kind. As a matter of fact, the only soil available to the builders was contained in a swamp and a lake about four miles from the course site. There were no roads over which dirt could be hauled and the trucks and grading machinery could not negotiate the soft sand.

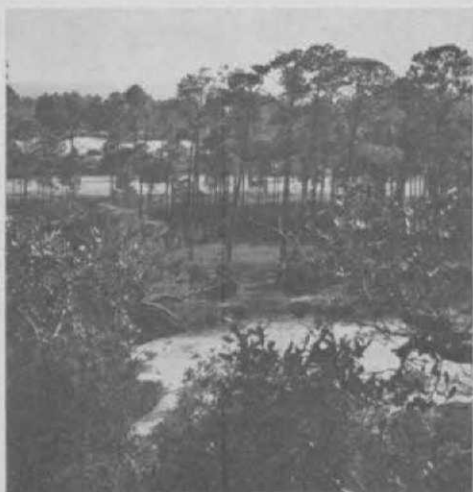
This gives you an idea of the brush that had to be cut away as Maddox crews proceeded with building of Dauphine course.
