Hoses, spigots and inconvenience are out with installation of new 650 gpm sprinkling system

An extensive, modern sprinkling system just completed at Ashbourne CC, Cheltenham, Pa. has increased the club's sprinkling capacity twenty-fold.

Ashbourne Increases Capacity Twenty-Fold

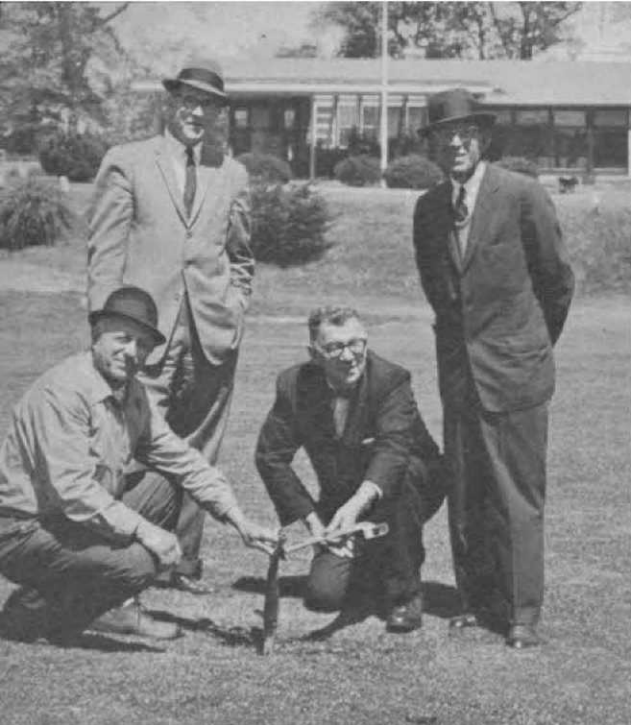
Ashbourne installation was directed by Joe Tagnon, supt. and Albert Krebs, pres. of Farm & Golf Supply, (holding sprinkler) and Edward J. Hennessy of Keasbey & Mattison Co., and Martin Sharp, Ashbourne's green chairman.

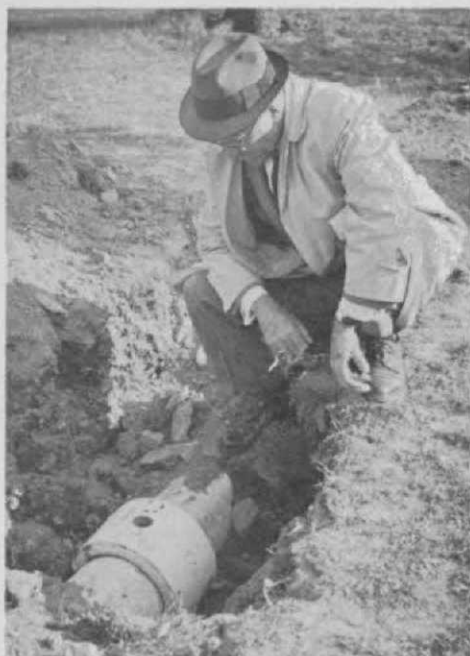
Ed Hennessy of K & M looks over a pre-tapped coupling, which simplifies installation of risers and snap valves.

increases. They also assemble easily and allow deflections up to five degrees at each joint. The couplings installed for lateral and riser connections were equipped with the recently introduced pre-tapped threaded brass inserts which eliminate the need for time-consuming field tapping operations.
