North Carolina CC, built in 1964, and 10th course in the Pinehurst area, offers plenty of hazards by way of the water, interesting tee situations and a semi-automatic system geared to irrigate the 7,000-yard course in easy stages The completion in 1964 of the North Carolina CC course in Southern Pines brought to a total of 10 the number of layouts in the Pinehurst-Southern Pines area. Many vacationers, on their way from the North to the Florida sunshine, never get further than this mid-point, once they stop over and play a litle golf on one of the tree-shaded courses.

## Lake Tapped for Irrigation

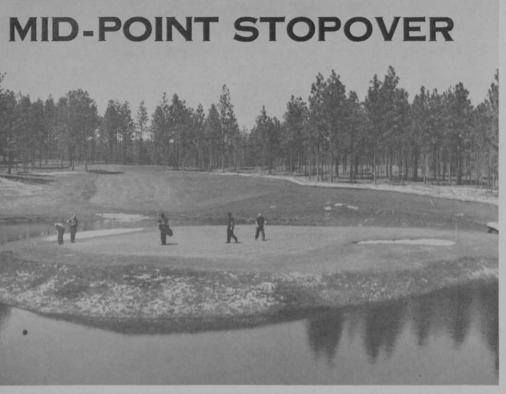
Golfers play 160-yard third hole at North Carolina CC with some trepidation. Green is not only surrounded by water, but is small enough not to allow much margin for error.

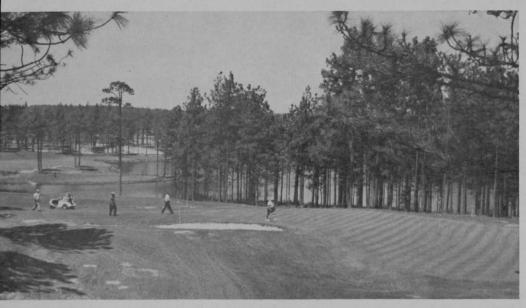
Eleventh hole doglegs to the left. There is plenty of open space on the right, but if golfer pushes one too far he invites trouble. Sixty-acre lake is in the background. (Below) Pump house, nestled in the pines, was built of materials that give it a hunting lodge look and to blend with other structures on the course.

As mentioned before, irrigation water is piped from the 60-acre lake through an 8-in. main. The pump house was constructed to look more like a hunting lodge than a pump house and blends well into the surroundings. The lake is 15 to 20 feet deep in some portions.
