# 'Super sheds' for course maintenance

*Whether a handsome old barn or a modern building, superintendents' sheds are no longer shanties.*

By VERNE FLOYD

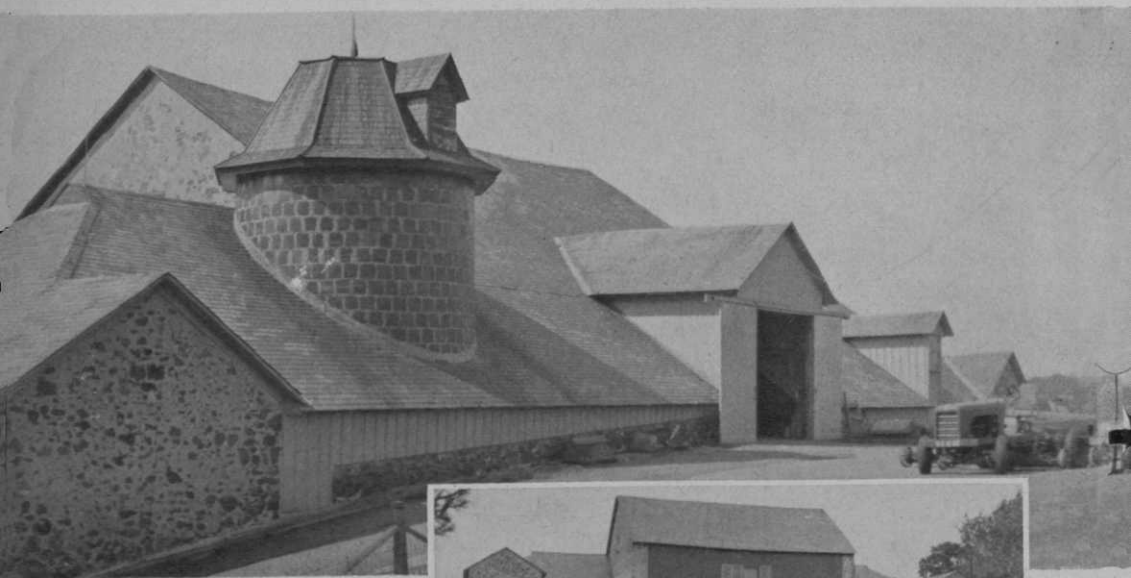
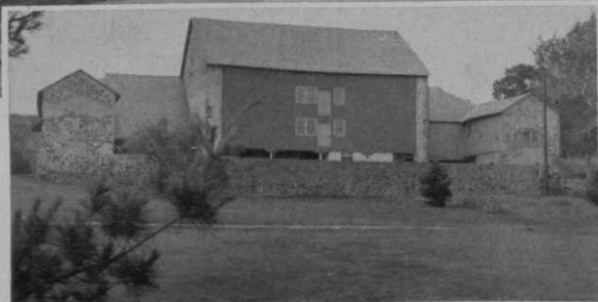
*Maintenance building at the Wilmington (Del.) CC is former dairy barn built around 1830. Inset shows front view; larger photo shows second floor at ground level in rear.*

there. First floor dimensions of the old but solid structure measure around 180' x 40'. In separately walled sections of the first floor, equipment for everyday use is kept, and here also are located the shop, soil storage, fertilizer and superintendent's office. Most active area of the former dairy barn is where the cows were milked. Here, on a concrete floor are the greenmowers, oil and grease, shop and plenty of room where 25 men eat lunch. In the silo, McSloy stores his chemicals.

On the second floor, which is ground level at the back of the barn, large equipment, such as fairway mowers and most

other tractor-towed accessories, sprinklers and pipe are kept.

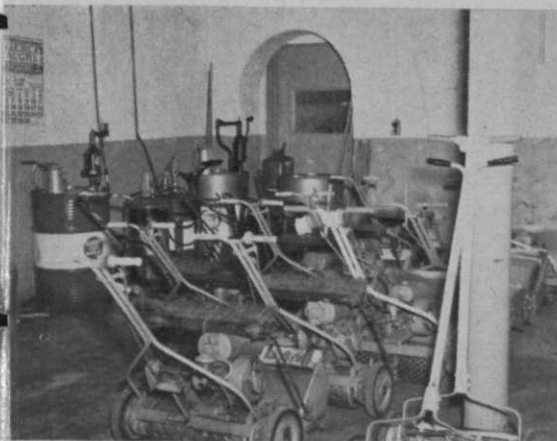
*Area where cows were milked (left) is now used for shop and mower storage. A few of the many signs used at Wilmington are shown above.*

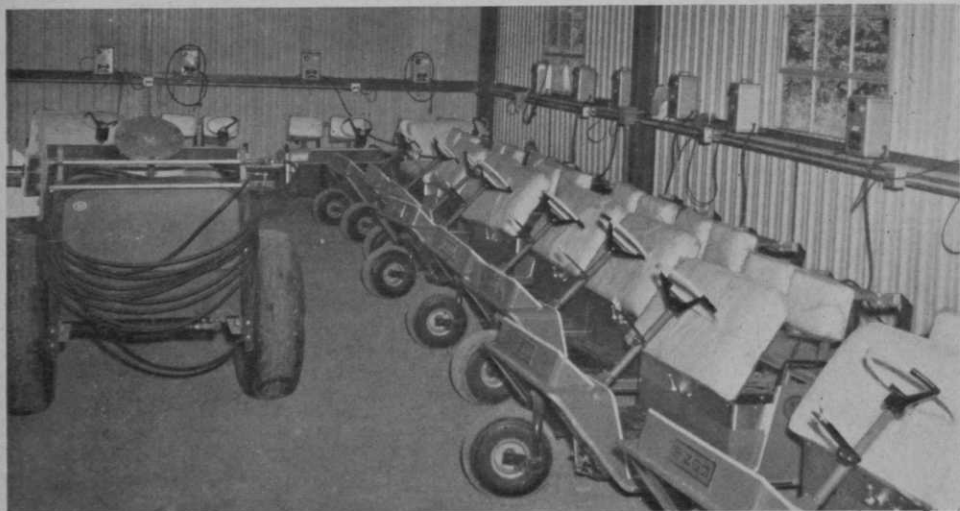
*Electric cars are stored at end of new Cavalry CC maintenance building in New York.*

A fireproof structure of Republic Steel Trusspan, the building is 140 feet long and 30 feet wide. Six bays 20'x30' each shelter the equipment and departmentalize the operation.

Six overhead doors, 10'x12' at the front, with four at rear, permit access from either side of the building to four bays. Windows are located in each floor at head level. With 10 steel girders per bay the roof can support any possible snowfall. Clearance height of the inte-

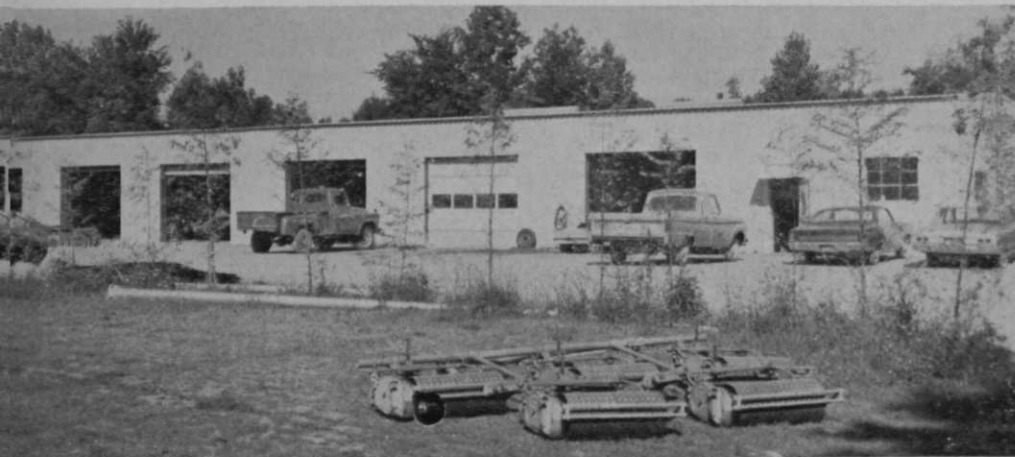
*Large doors in Cavalry maintenance building lead into six separate bays of shed.*

rior is 14 feet. It is equipped with steel sash windows throughout, with fluorescent lighting adequate for night work. Much of the building is insulated and has infra-red heaters.

Floor of the building at Cavalry CC is concrete and three rooms 10' x 10' each at one end serve for office, utility and storage, locker and toilet.
