# Flood problems down the drain

*Although this New Jersey club had to wait five years to test out its improved drainage, the summer of '67 proved it right.*

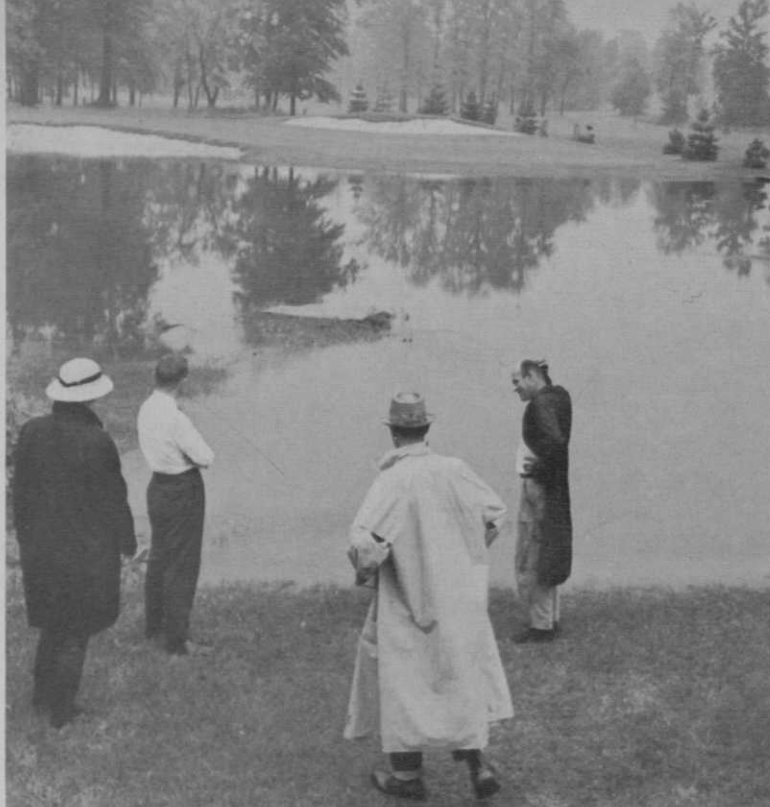
Employees of the Upper Montclair Country Club study flooding of the sixth green at a siphon culvert on the main channel, at top. The sixth green as it appears today, above. Downstream improvements have made the operation of the siphon culvert much more efficient.

Channel improvement—deepening and widening—was Waters' suggestion for the main ditch, as well as replacement of two bridge culverts with wooden foot bridges.

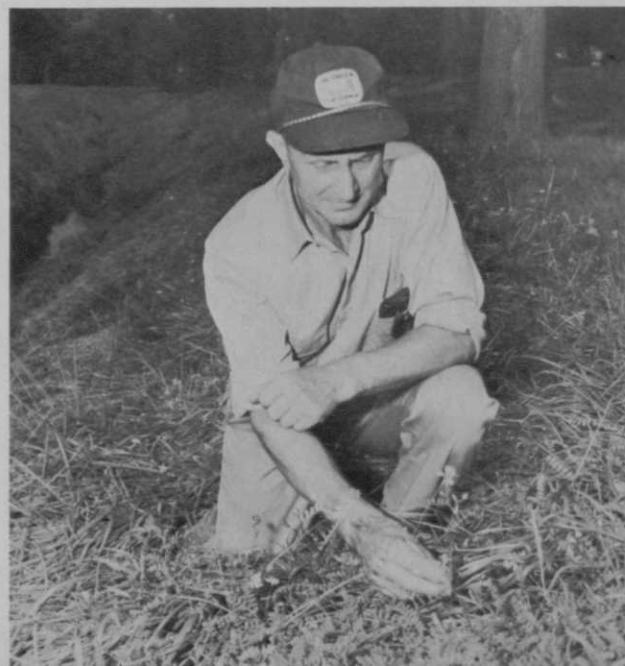
Greens superintendent, Karl Ostberg, inspecting growth of crownvetch and tall fescue on the banks of the main drainage ditch.

Club directors gave their hearty approval, and construction began that winter on the drainage ditch. First, the culverts were removed. Then, 1,300 feet of the main ditch were lowered and the bottom was widened to six feet. The sides were sloped on a 1½-to-1 ratio and seeded with inoculated crownvetch and Kentucky 31 tall fescue. This legume-grass mixture is especially effective in controlling erosion on steep banks. The banks were heavily limed at a rate of 100 pounds per 1,000 square feet and fertilized with 10-6-4 at a rate of 25 pounds per 1,000 square feet. They were then mulched.

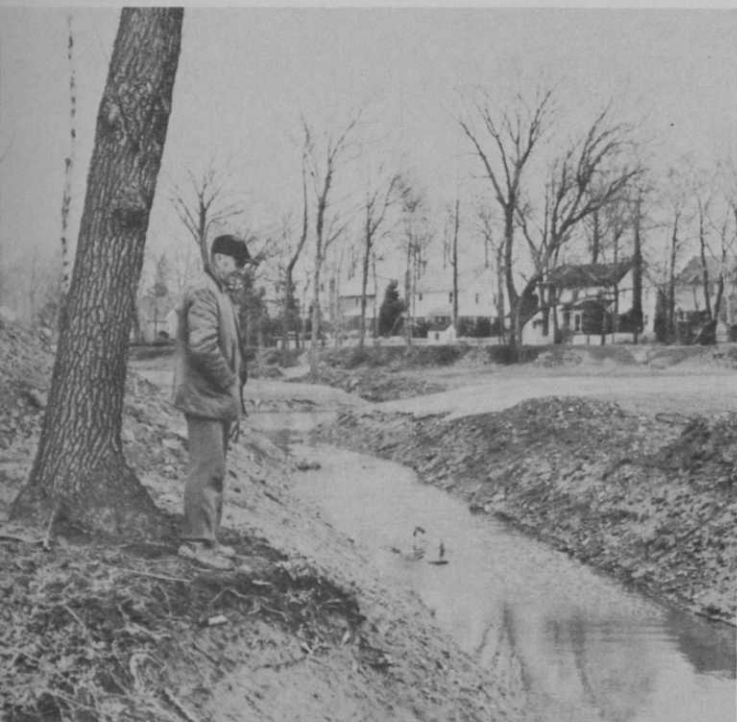
Karl Ostberg examines main drainage ditch shortly after channel improvements were made. Around 1,300 feet of the ditch were lowered and the bottom widened.

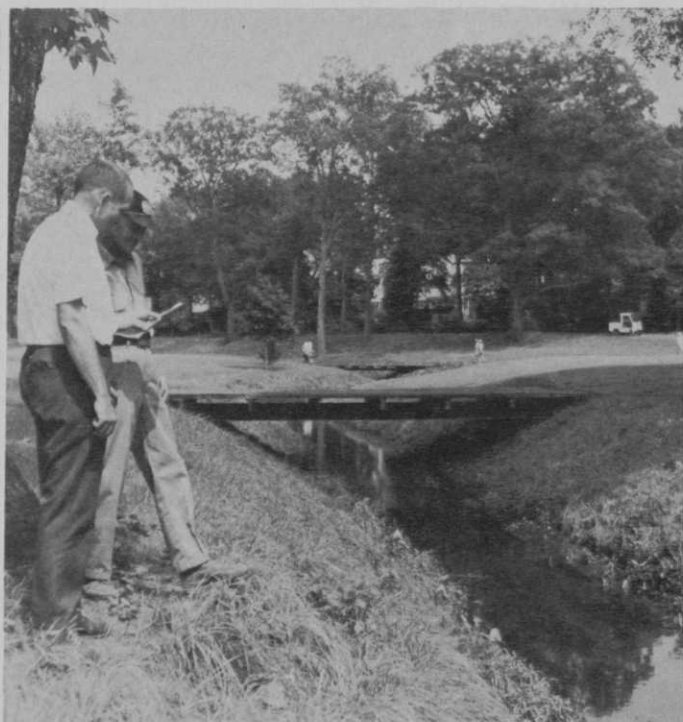
Karl Ostberg, right, and Harold Waters, SCS soil conservationist, discuss results of seeding ditch banks. Proper seeding has improved ditch's appearance.

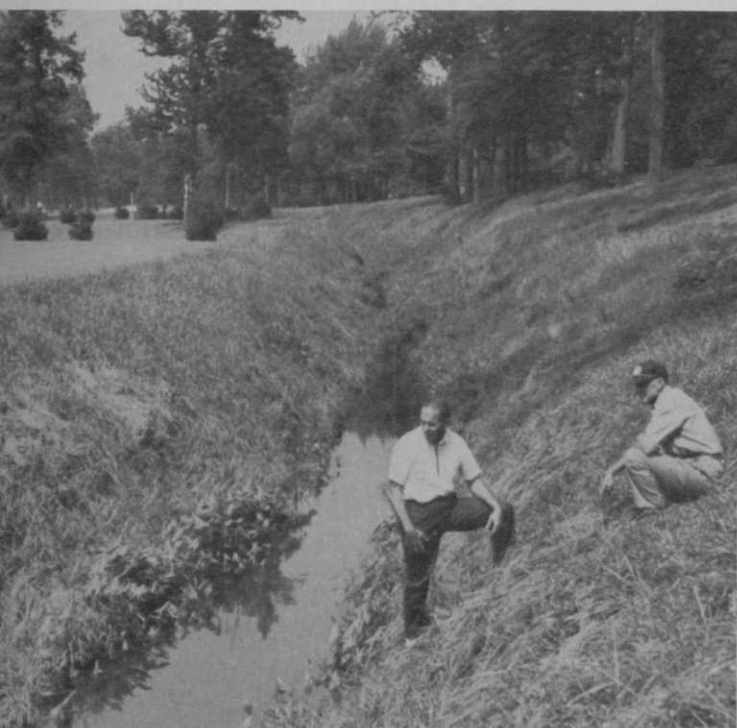
Harold Waters, SCS soil conservationist is shown the high-water mark of a recent storm by Karl Ostberg, superintendent at Upper Montclair Country Club.
