■ CYPRESS POINT CLUB, PEBBLE BEACH, CALIF.

On the Edge

As the signature holes of Cypress Point threatened to fall into the Pacific Ocean, the club formed a new, stronger shoreline with sculpted concrete

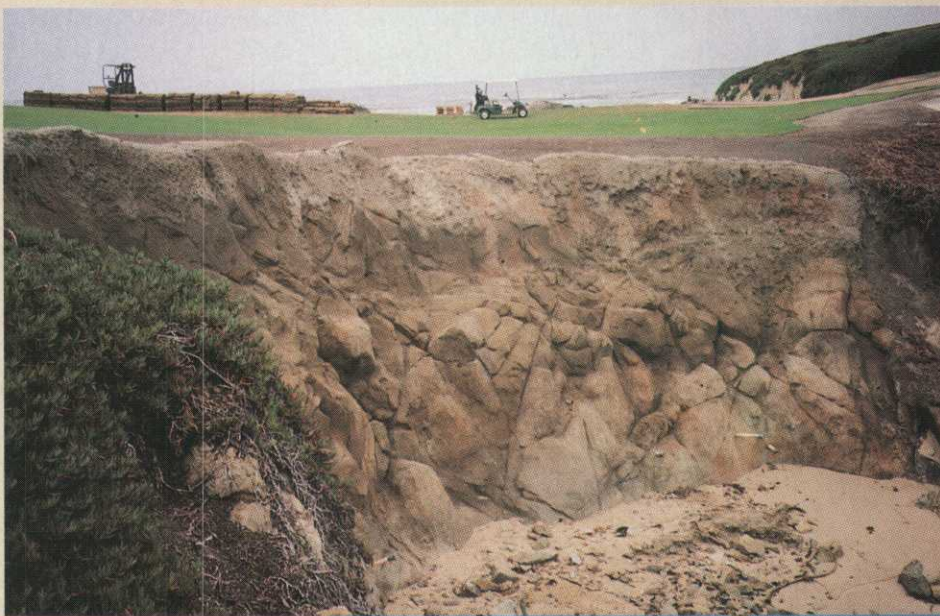
The finished product (above) started with drilling tie backs into the shoreline to prepare it for the frame of the structure to be built.

Sculpted concrete, artistically molded to blend in with the rest of the shoreline, saved the club's signature holes.

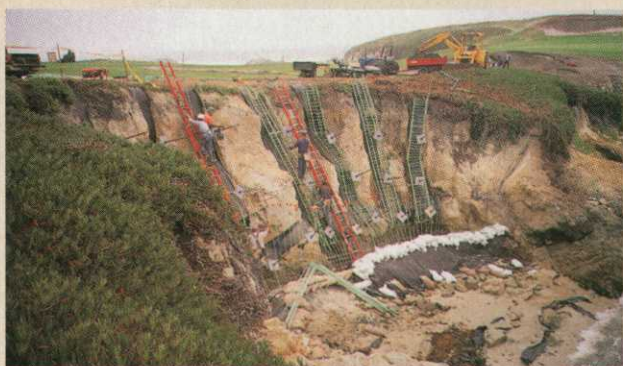
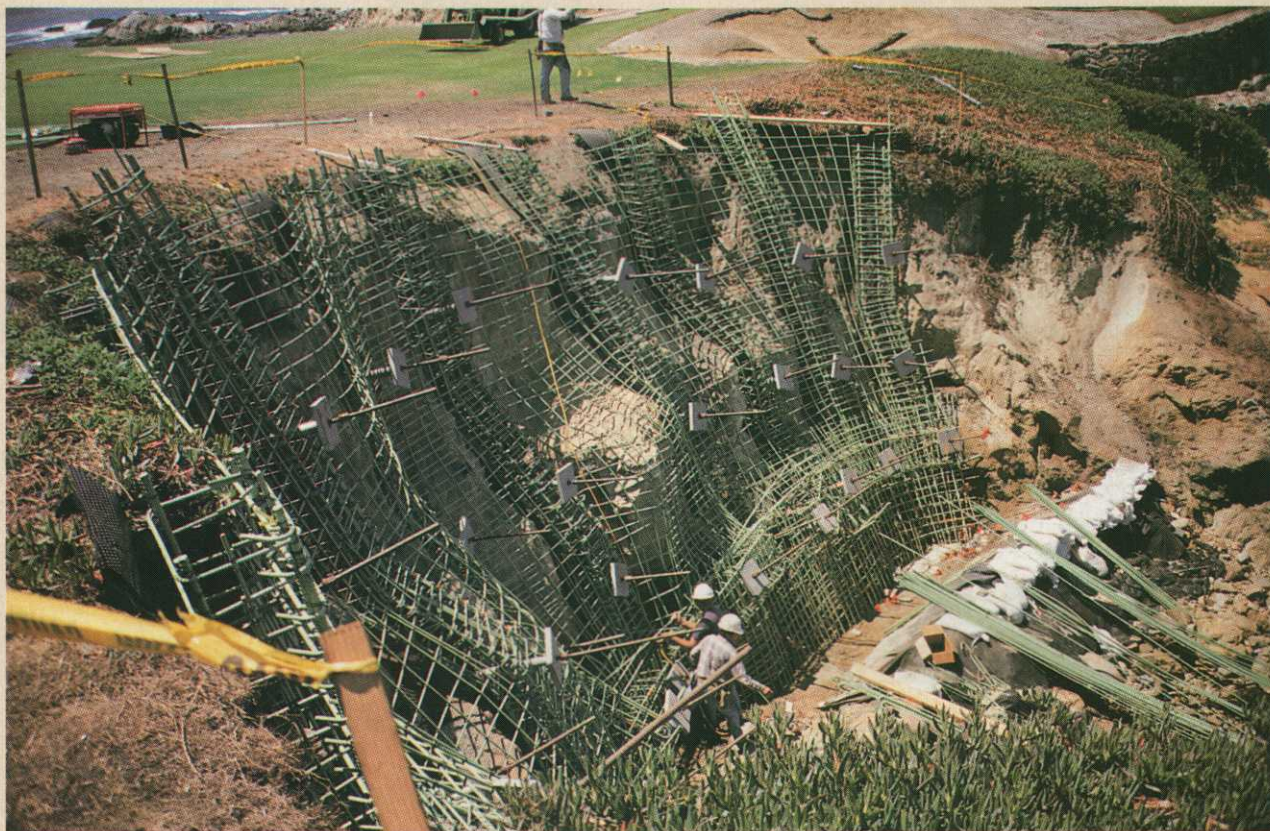
CemRock Landscapes built a steel anchoring system (left) into the side of Cypress Point’s existing shoreline. Then the company built a scaffold-like structure, which provided a frame for the fiber-reinforced concrete.

"We come in with fiber reinforced concrete and blow it onto the steel framework we've created," Allen says. "Before it's even dry, we send our artists in to shape it and create a natural rock look to it. That's the most exciting part of the project."

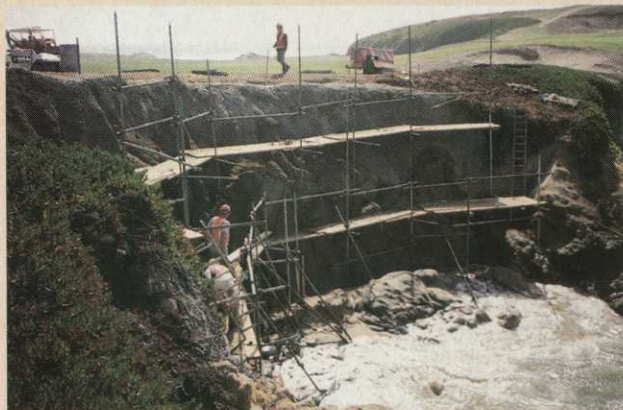
The first layer of 8 inches to 16 inches of structural concrete anchors the structure to the existing seawall.

mation's steel framework into the side of the cliff. Then a base of 8 inches to 16 inches of structural concrete was sprayed in the holes to anchor it to the wall.
