Getting to the Root of the Problem

Course dug deep to eradicate its mutant bermudagrass to prepare for fairway reseeded

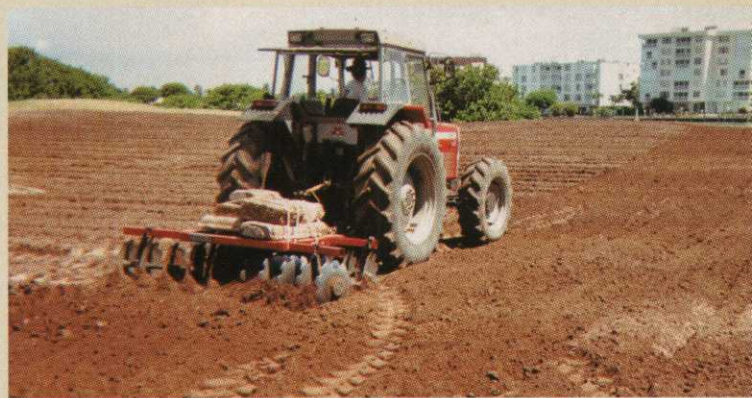
To kill the mutant cultivars of bermudagrass, the soil had to be cultivated more than 8 inches deep.

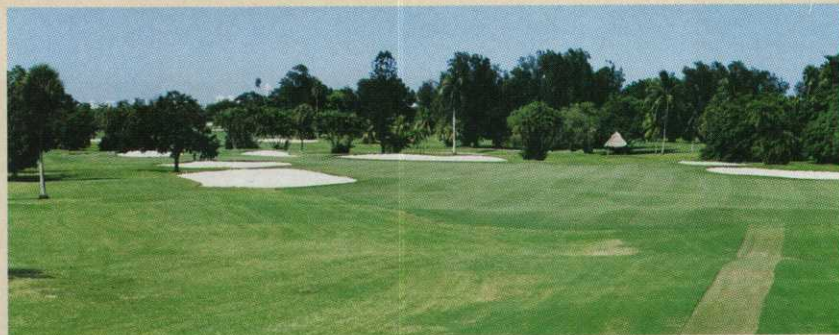
The regrassed fairways have grown well, without any drastic contour changes.
