Winged Foot Gets a Leg Up...with major irrigation upgrade

Real Life Solutions: Winged Foot

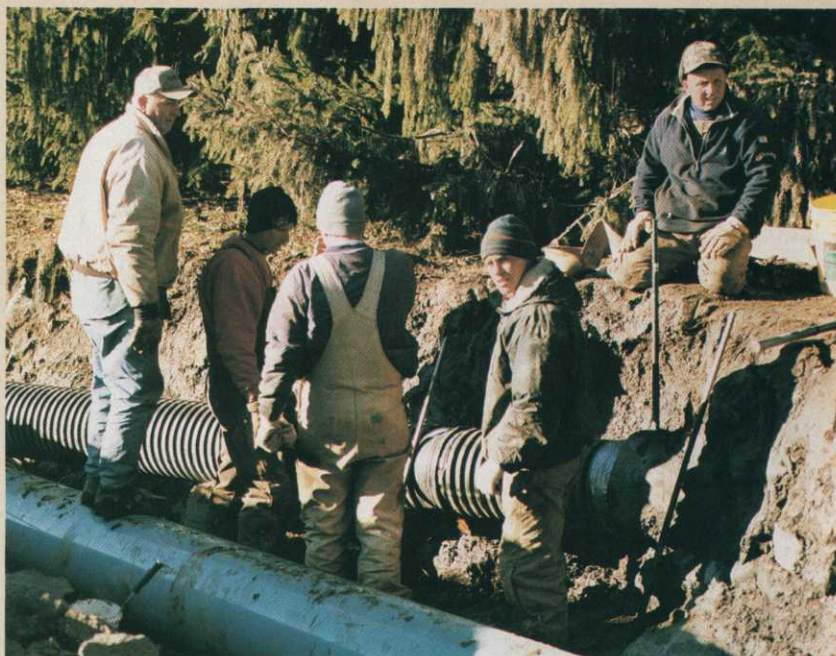
Winged Foot is using a 50,000-pound machine to blast through the course's hard granite.

Leibold's solution was a track trencher from Vermeer Manufacturing Co. that would cause less disturbance than a conventional rock hammer method. When the original model proved to be ineffective, Leibold turned to a Vermeer 955, a 50,000-pound machine normally used for the installation of water or sewer lines.

Leibold says the boom was shortened since the maximum depth mainlines are buried about 50 inches, much shallower than normal sewer and water lines. The Vermeer was further customized when the boom was filled with lead to keep it from bouncing off the rock.

While this means of trenching may appear to be overkill, it is at times barely enough. When encountering some of the hardest granite, the trencher can only carve about 80 feet a week of the 48-inch wide, 50-inch deep trench. But no matter how hard the stone, the Leibold crew just keeps going.

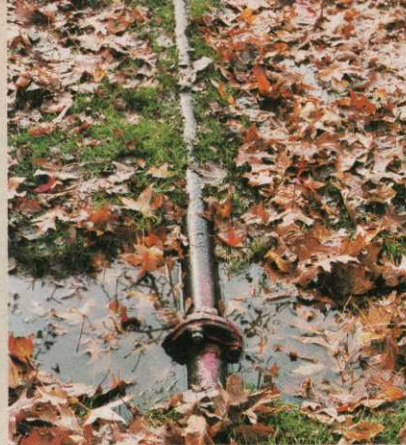
In some places, old pipe sits above the ground, just a few yards off the fairways.

Wires and mainlines are buried anywhere from a few inches to a foot below the ground, depending on the rock. In some cases, pipes sit above ground in the rough lines, just a few yards off the fairways.
