After the Deluge

The shock and awe of **large-scale flooding** can be blinding to superintendents. But it can also open their eyes on how to **prepare for future rain events**

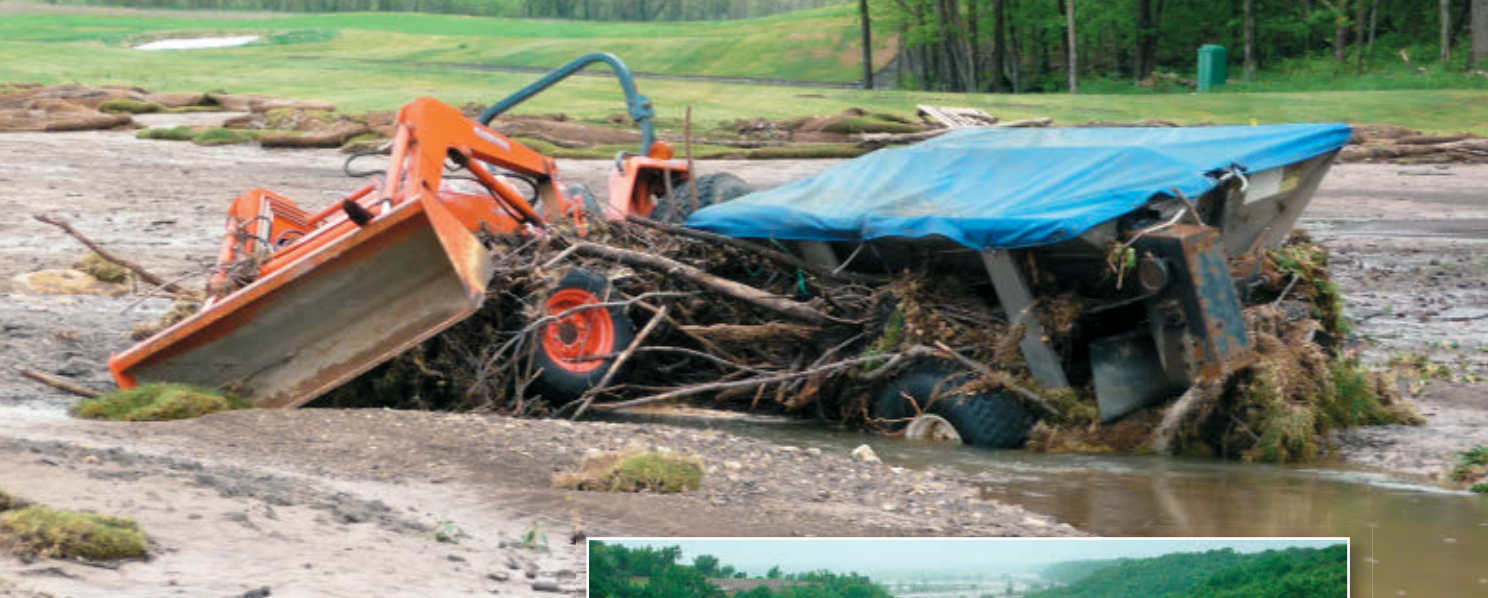
Some of the hardest-hit courses during spring flooding in Oklahoma last year were those under construction, such as the Patriot Golf Course in Owasso, Okla. The photographs here tell the story.

Drainage inlets became clogged with sod and rocks, and boulders that had moved to the bottom of the canyons during construction littered the greens. One

rock blocked a 36-inch drainage inlet.

Construction crews used the destroyed areas as access points to create check dams with large boulders to slow water for the next rain event.
