# Reducing Watershed-Scale Phosphorus Export through Integrated Management Practices

## Objectives:

Demonstrate and quantify the watershed-scale benefits of implementing filter socks and application setbacks from surface inlet structures, limiting phosphorus application to rates less than or equal to soil test phosphorus recommendations, and using the two practices in tandem.

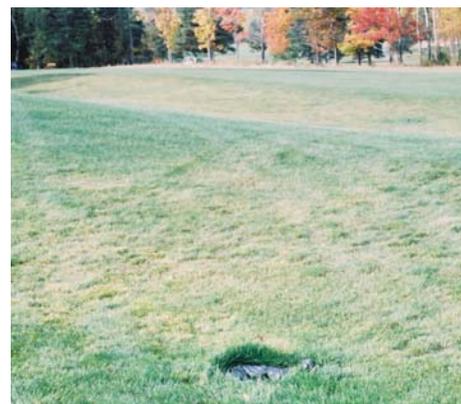
A surface inlet is placed at the bottom of the pothole to rapidly remove water that collects in the depression.

The experimental site is located on Northland Country Club (NCC) golf course located in Duluth, MN. Specifically, the study area is a 21.8 ha subarea of the golf course that contained 7 greens (0.3 ha), 8 tees (0.5 ha), 10.5 fairways (3.95 ha), grass roughs (8.1 ha), and 8.95 ha of unmanaged mixed northern hardwoods. The course is characterized by several micro-depressions or 'potholes.' In order to facilitate drainage, these potholes

are often drained by tapping into the existing subsurface drainage network. A surface inlet is placed at the bottom of the pothole to rapidly remove water that collects in the depression.

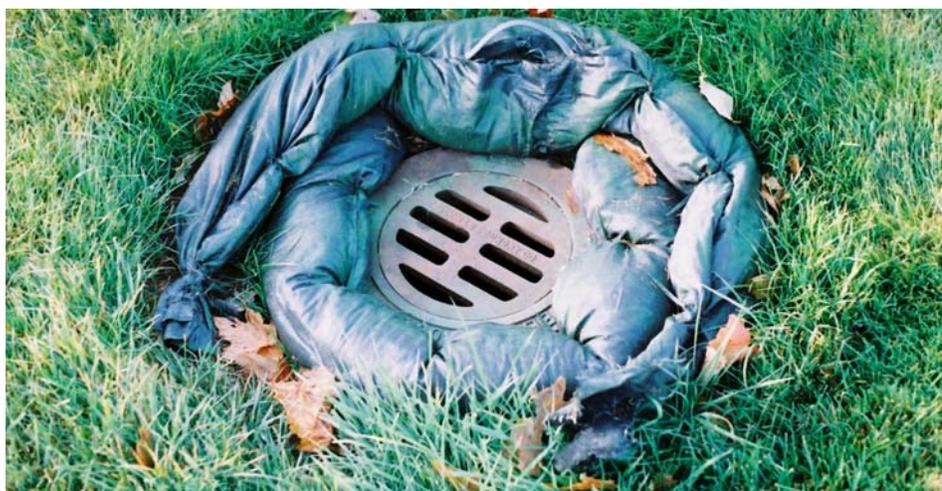
In March of 2011, filter socks were installed around each inlet within the eastern portion of the golf course study area. The filter socks were filled with 75% steel slag, 2.5% cement kiln dust (CKD), and 22.5% silica sand.

In March of 2011, we installed filter socks around each inlet within the eastern portion of the golf course study area. The filter socks were filled with 75% steel slag, 2.5% cement kiln dust (CKD), and 22.5% silica sand by volume.

- Filter socks containing 75% steel slag, 2.5% cement kiln dust, and 22.5% silica sand were placed around all surface inlets draining the eastern portion of the course.
- Hydrology, dissolved reactive phosphorus, and total phosphorus data on one drainage outlet with the filters and one drainage outlet without the filter socks have been collected.
- The findings should provide an assessment of both cultural and physical approaches to reduce phosphorus export from managed turf systems.
