## Sportsfield Drainage: Learning from Mistakes (Case 1)

DR. BOB SHEARD, P.AG., AGRONOMIST, GUELPH TURFGRASS INSTITUTE

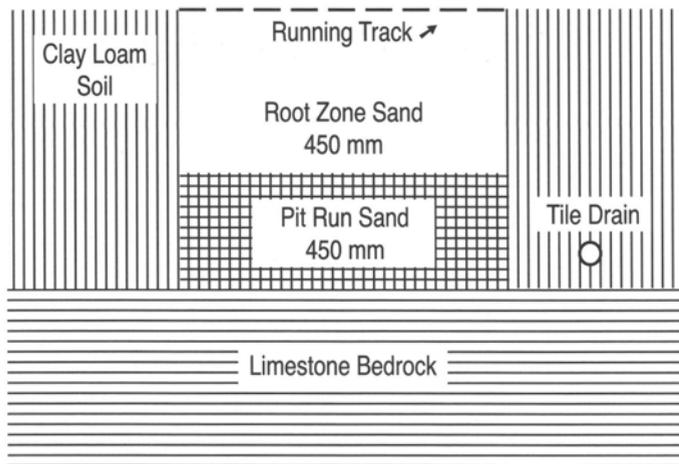
The architect's design called for the removal of the clay loam material down to the bedrock and backfilling the first 45 cm with pit run sand. The final 45 cm was scheduled to be a selected sand. A running track was constructed around the soccer field on the clay loam subgrade. A single drain line was planned beneath the track to prevent frost heaving and cracking of the rubberized surface (Figure 1).

Figure 1: A schematic drawing of the design of the sportsfield.

The design. Sand surrounded by highly impervious clay loam is analogous to a cereal bowl of cheerios filled with milk. The bowl became full and ran over.

One may ask: "Would the tile line under the running track not drain the water out of the sand"? Not likely. Why? Because of the low permeability of the clay loam soil in which the drain was laid. Furthermore, even at a hydraulic conductivity of 56 cm per hour, it would take a minimum of 2.5 days for the standing water at centre field to flow to the side lines. It might also be assumed that lateral flow of water without the force of gravity may be less than 50% of the vertical flow.

The solution to the problem was to install four drainage lines running the length of the field using a tile machine which plowed in the drains to minimize surface disturbance and prevent mixing of the pit run sand with the selected sand. Unfortunately, the already installed irrigation lines ran perpendicular to the drains which meant they all had to be cut before the drain plow went through. With a good outlet in place, the field drained as it should.
