SFMANJ District 4 Synthetic Infill Maintenance Day Photo Recap September 19, 2007 - Recchino Field Complex, Haddon Township, NJ

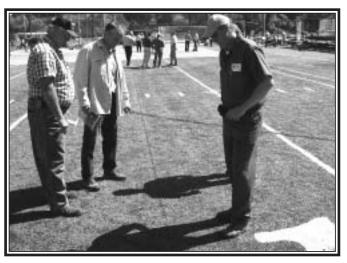
Not exactly seamless. District 4 Meeting attendees observe a large, not-easily-repairable seam in the playing surface of this synthetic infill system.

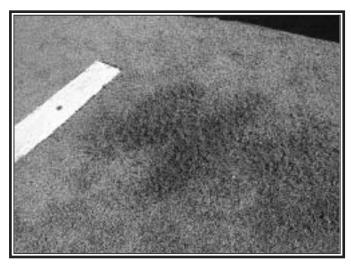
Significant fiber deterioration was evident directly in-front of the girls' softball pitching rubber.
