Irrigation Redesign to Conserve Water

Course No. 2 at the Pinehurst Resort
Bob Farren, director of grounds management

Pinehurst, N.C.

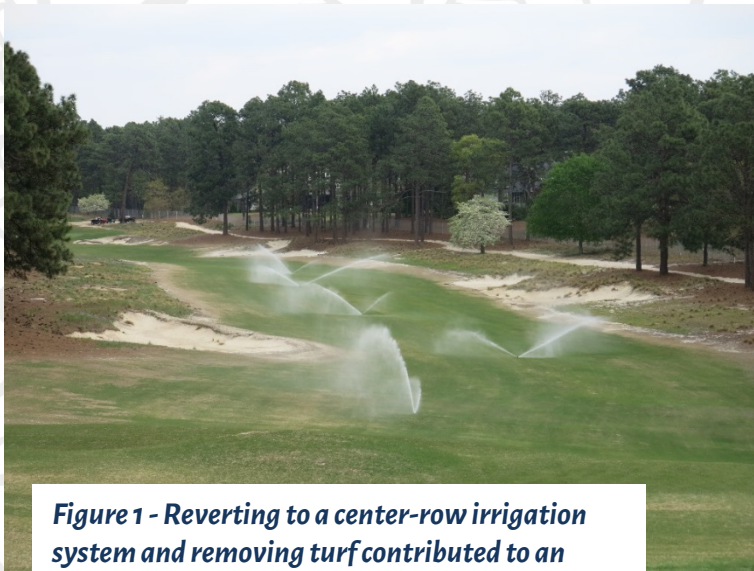
Figure 1 - Reverting to a center-row irrigation system and removing turf contributed to an annual water use reduction of approximately 60 percent.

There were two significant revelations very early in the reconstruction process. The first was the realization that, based on old irrigation notes and drawings, much of the original center-row irrigation mainline pipes still were in place. The original mainline irrigation pipes were used as a guide to determine original fairway widths and contours.

The second revelation was an engineered, government, aerial photograph taken in December 1943 that gave us great confidence in proceeding with Coore and Crenshaw intuitions as we reestablished the turf footprint. The restoration reduced irrigation coverage from 1,150 sprinkler heads to 450 sprinkler heads. Most of the remaining sprinkler heads are associated with primary playing surfaces like greens, surrounds and tees. Fewer than 100 sprinkler heads are used to irrigate fairways.

The elimination of turf and irrigation coverage has reduced annual water consumption by as much as 60 percent. It is important to note that only surface water from on-site lakes is used for irrigation. The original goal of the project wasn't necessarily to reduce water use but it was a wonderful byproduct of the restoration.
