Tree Management To Protect Renovated Cart Paths

Pine Lake Country Club Richard McDaniel, CGCS, superintendent Charlotte, N.C. 28227

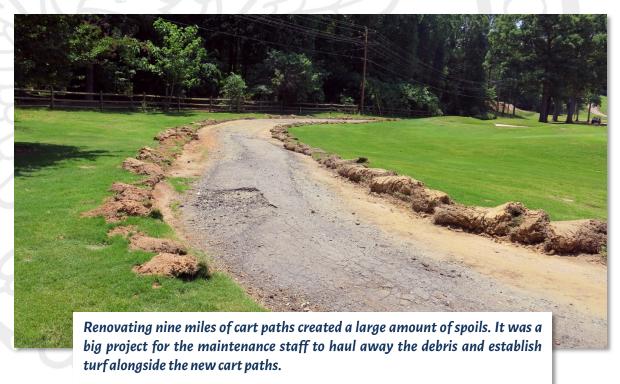
Damage from tree roots had compromised the old cart paths. To avoid this problem in the future, over 500 trees were removed from alongside the new cart paths.

A plan was developed to install new asphalt cart paths and address tree issues alongside the new paths. Any tree within 12 to 15 feet of the paths, around 500 in total, was slated for removal. The roots from these trees had caused the most damage to the cart paths in the past. A USGA agronomist assisted in identifying the trees that were most likely to cause problems for the new cart paths. Trees that did not cause cart path or turf issues would be preserved. The Board of Directors approved a bond for \$400,000 that included both the new asphalt paths and the complementary tree work.
