CONTRACTORS DESCRIBE PROJECTS CHOSEN AS 1979 AWARD WINNERS

by Bruce F. Shank, Editor

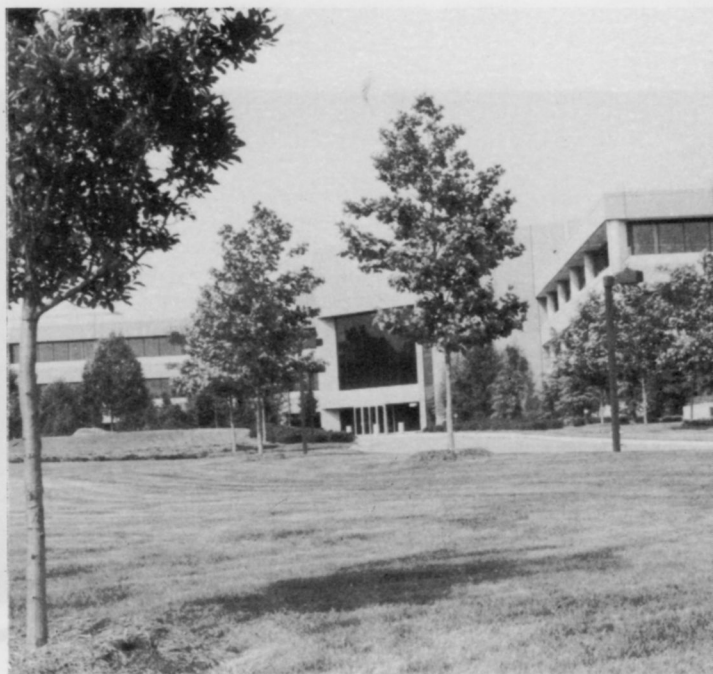
View from entrance of Martin-Marietta headquarters.

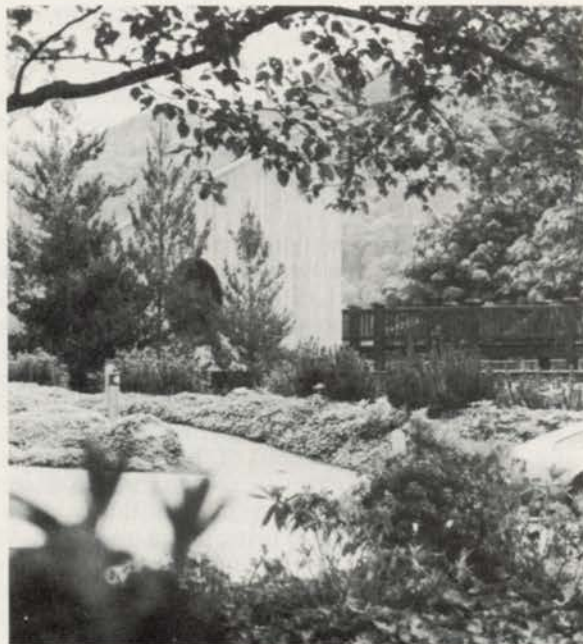
Six acres of groundcover make the Port Ludlow maintenance job especially challenging.

Groundcovers are fertilized regularly. Both ivy and Hypericum are pruned to maintain a natural transition between turf and groundcover areas. Parking lots are below grade and surrounded by berms to preserve the natural appearance of the area.

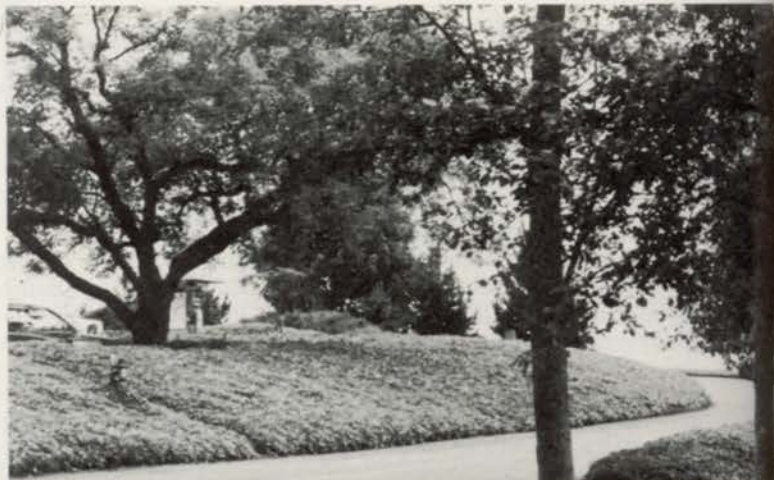
Evergreen decided on a three-phase program to upgrade and maintain the property. The first was to clean out beds and reestablish weed control and native area encroachments. Watering, fertilization and turf improvement practices were implemented.

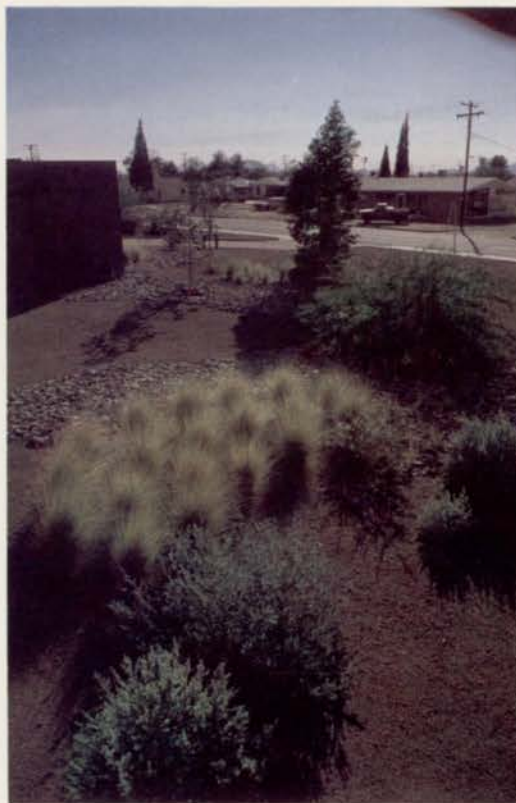
Drought tolerant plants as they appear at dawn around the Tucson Credit Union.

Instead of turf or groundcover, decomposed granite was used. Unlike pea gravel, decomposed granite does not show foot prints or shatter. This was important due to the large amount of foot traffic at the building and because a bus stop was located next to the property. Underneath the granite, gravel mill reject was used instead of topsoil. This eliminated any trouble from weed seeds. Usually, preemergence herbicides are needed to control weeds in gravel yards.

Drought tolerant plant species including fountain grass, Texas ranger, eucalyptus, mesquite and *Cassia artemisoides* were used in designs around granite boulders. A drip irrigation system provides water when needed at a cost of less than \$30 per month. Part of the two acre site is covered with brick walkways illuminated by architectural lighting.

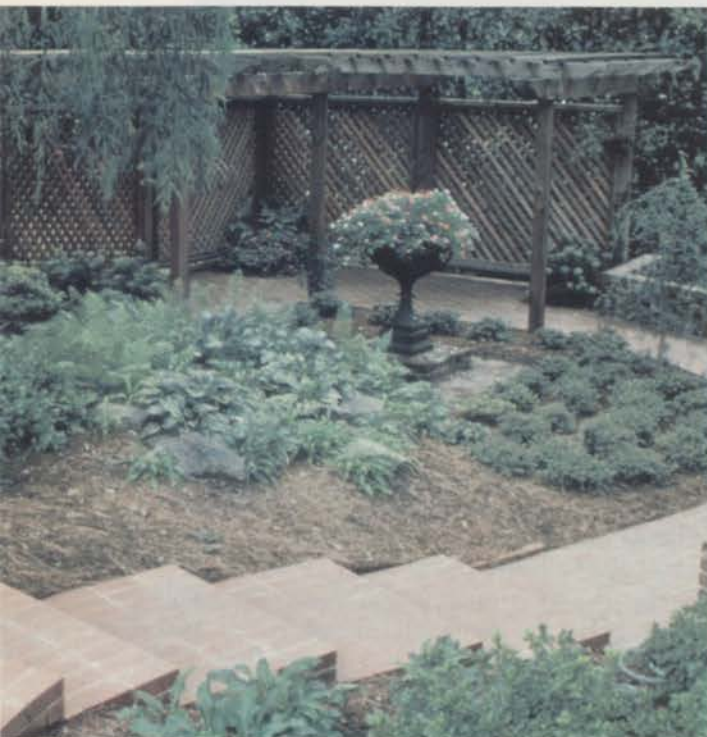
Arbor at rear of Jones residence ties back of yard with house.

An arbor was constructed as an activity area and to tie in the back of the property with the rest. A curved walk to the arbor gives the garden a feeling of being much larger than it really is.

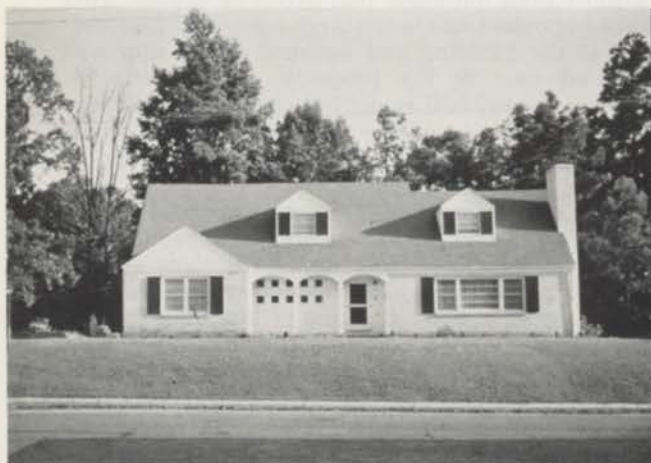
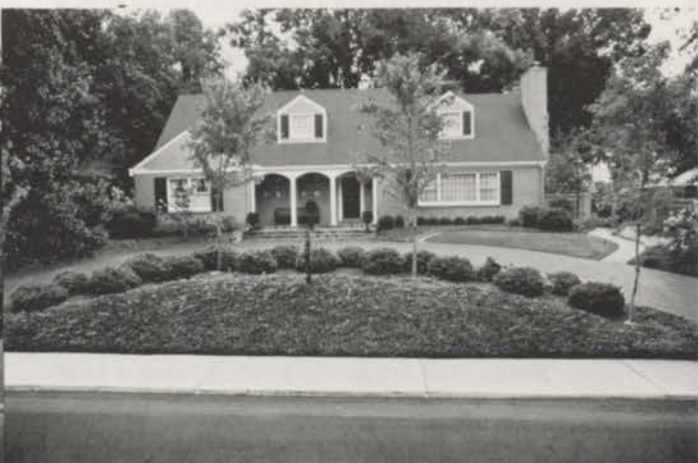
Stark appearance of Jones residence before (left) and more inviting appearance after professional landscaping.

white, positioned on top of a steep grass-covered slope to the street. Turf quality was poor and there were very few landscape plantings. The net effect was a cold, glaring appearance.

Gibbs recommended the house be painted in a softer shade, a circular drive be built, groundcover planted on the slopes, and installation of a brick walk bordered by fine turf. Shade trees were planted to provide a canopy effect.

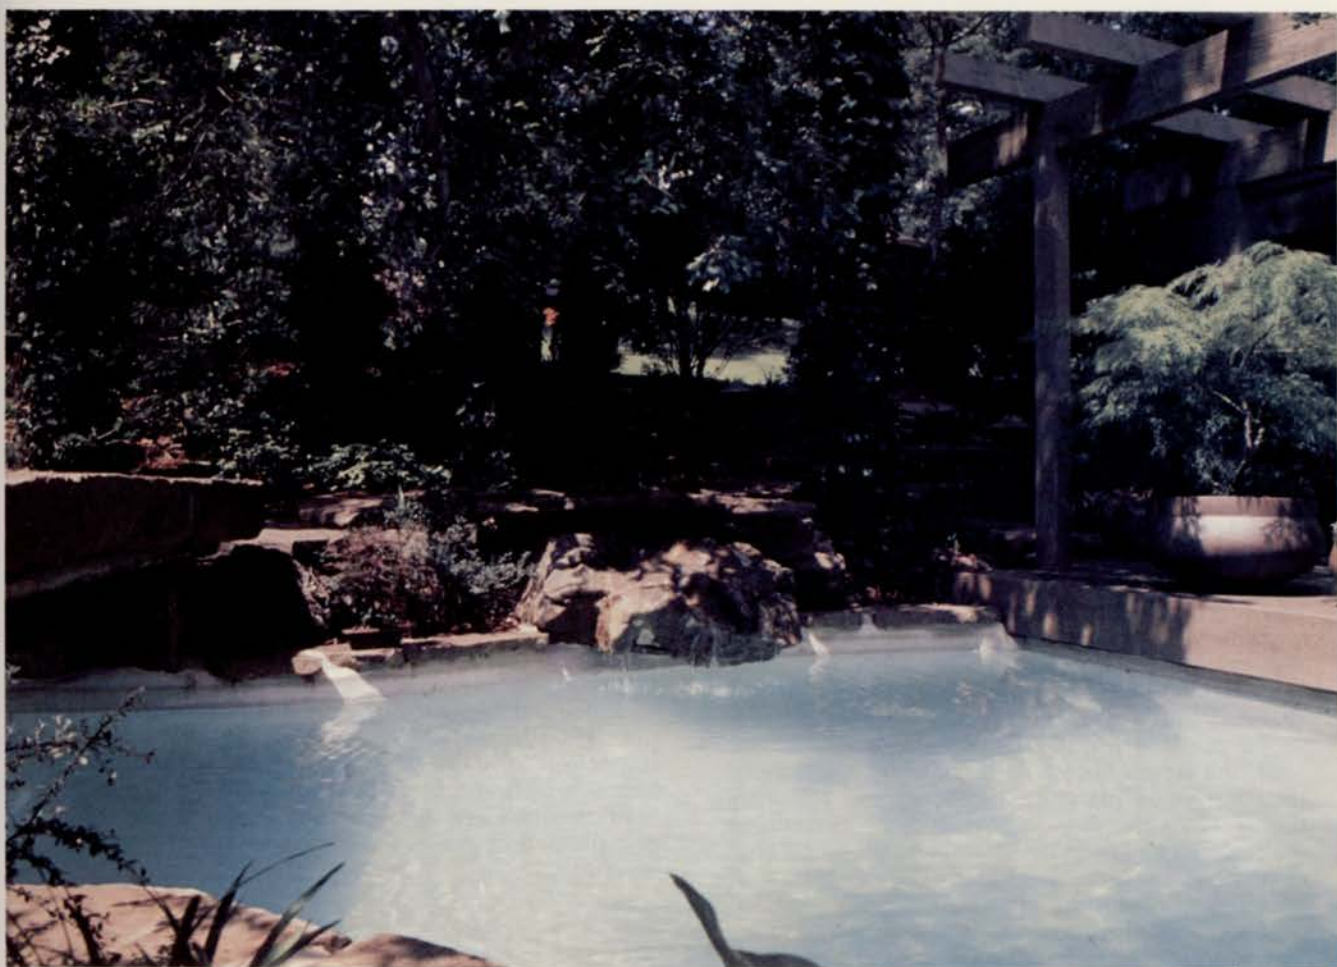
Looking over pool and waterfall toward street from Lackey residence

To add to the more natural appearance of the pool, chrome ladders and diving board were eliminated, steps were built into the pool wall at several locations and for diving a large stone was cantilevered out over the water. Also, to add interest a small waterfall was located close to the bridge stone. This waterfall is connected directly to the circulation system of the pool filtration system. The pool inlets were also adjusted upward to add additional water motion.

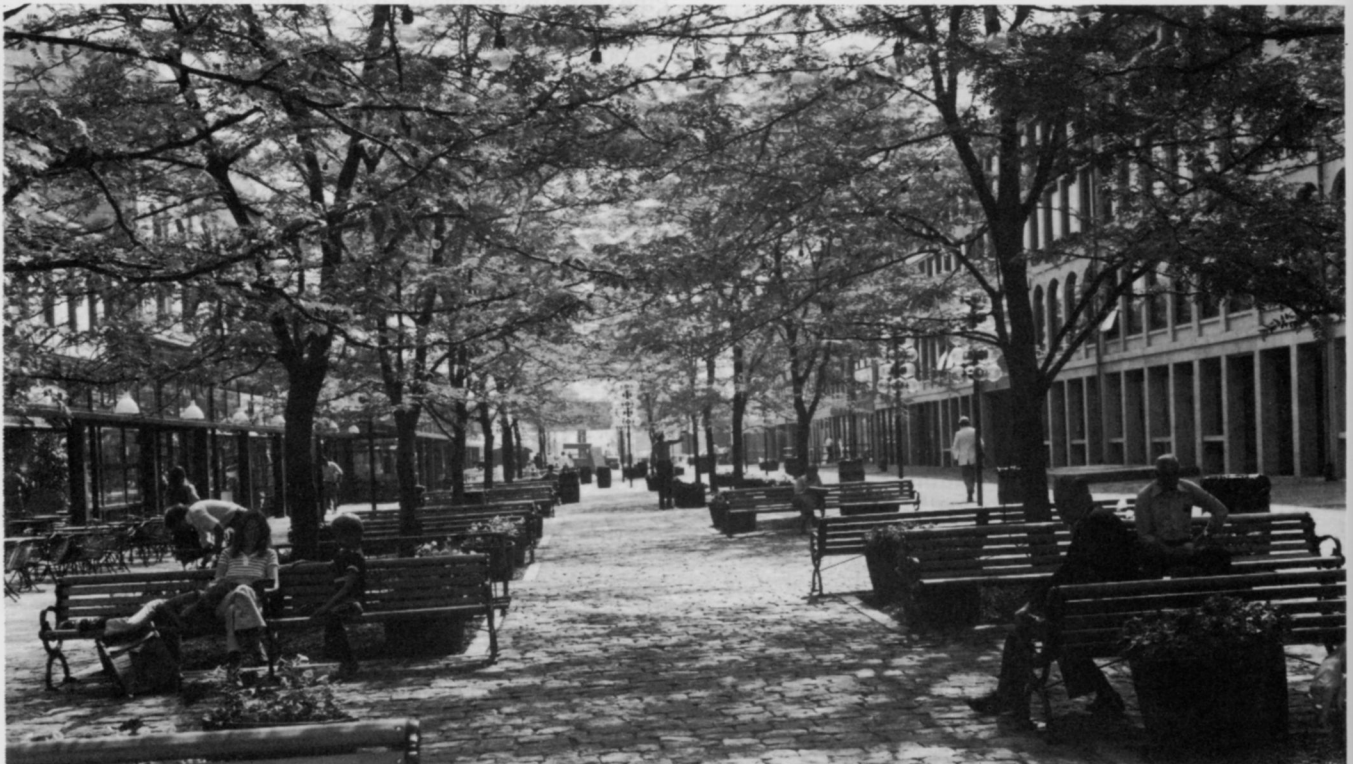
Faneuil Hall Marketplace's new look.

The results were spectacular and the trees were in a week before deadline. The deadlines were important because the trees had to be in place prior to cobblestone paving. The 22 trees 30 feet above the cobblestone walkway buffered the wind, stopped the glare and provided a soft light and warm atmosphere, and replaced the noise of traffic with the rustle of leaves.

Frost and Higgins currently maintains the mall plants with watering, spraying, pruning and inspection. Today, the marketplace contains 36 honey locusts and three nine-inch caliper lindens. Six three-inch locusts are in large planters with the rest planted at grade, surrounded by cobblestone walkway.

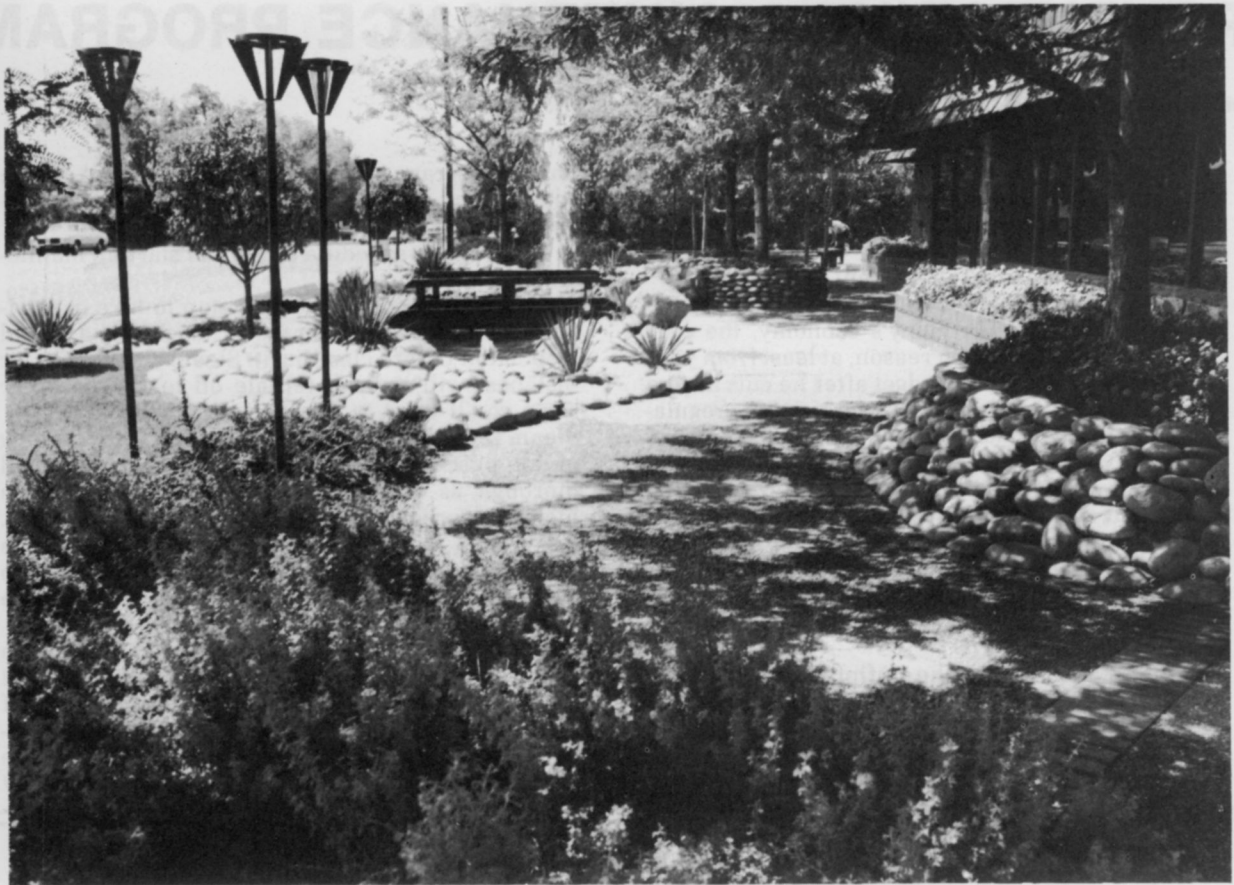
Twenty-nine tons of river rock were hauled from mountain streams to provide a natural appearance.

LA Don Godi commented that the site is small with no natural features to really capitalize on, except for a few trees. Godi planned a mound and tons of stream rock to act as natural features.

A rock and concrete stream winds through the design. Since the site is small, plant beds with floral displays and groundcover replaced turf. Honey locusts provide canopy and are highlighted during the night with overhead, indirect lighting.
