## County Stadium gets a new water supply

by Bernie Rupp, Milwaukee Brewers

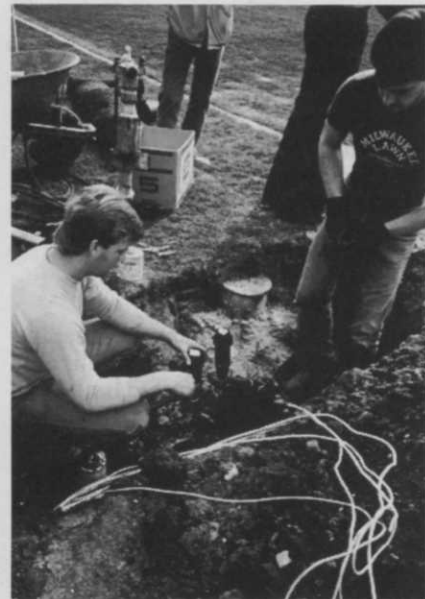
Workers from Milwaukee Lawn install the Toro sprinkler heads.

They decided that the Toro 640 irrigation system would be best for use. Fifty-seven rotary, gear-driven, pop-up heads were installed. They are constructed of cycloc plastic with spring-loaded retractors, delrin gears and locking caps with check valves.

All irrigation heads were installed on swing joints. The heads were positioned 1 to 1½ inches below the finished grade. Sprinkler head connections were made to the existing 3-inch PVC main. Each irrigation head is controlled by a remote electric valve placed in a control box next to the irrigation head.

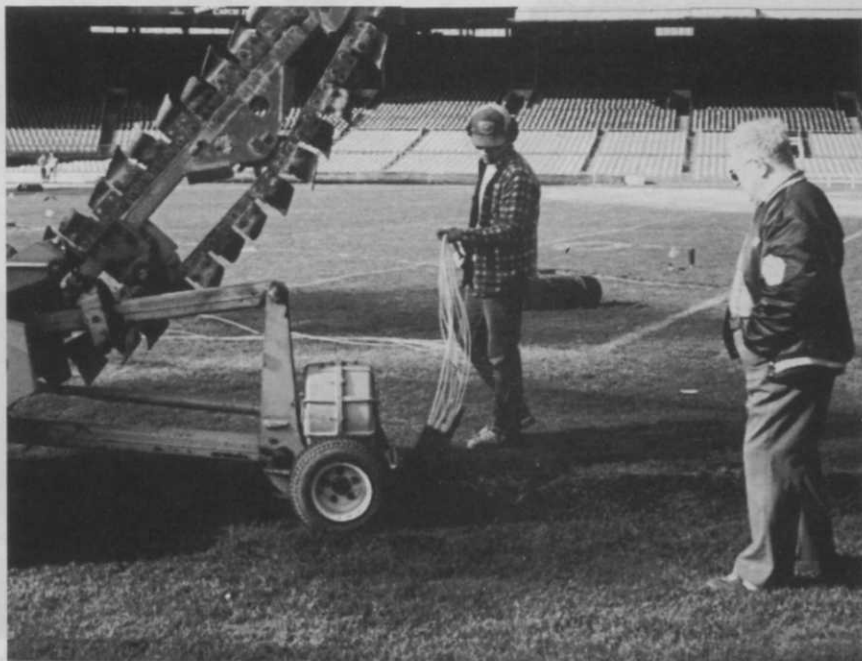
Harry Gill (right) supervises installation of the irrigation pipe and wires through slit sod. "The only places we had to remove the sod was when we came to a sprinkler head," Gill notes.

The pipe used for the irrigation system is polyvinyl chloride pressure pipe rated at 200 psi. The piping and wiring were installed using a vibratory type apparatus. Pipe was placed 18 inches below grade.
