Vinyl wall solves erosion problem

Look to this case study for a way to solve extensive creek erosion with long-lasting vinyl bulkheads.

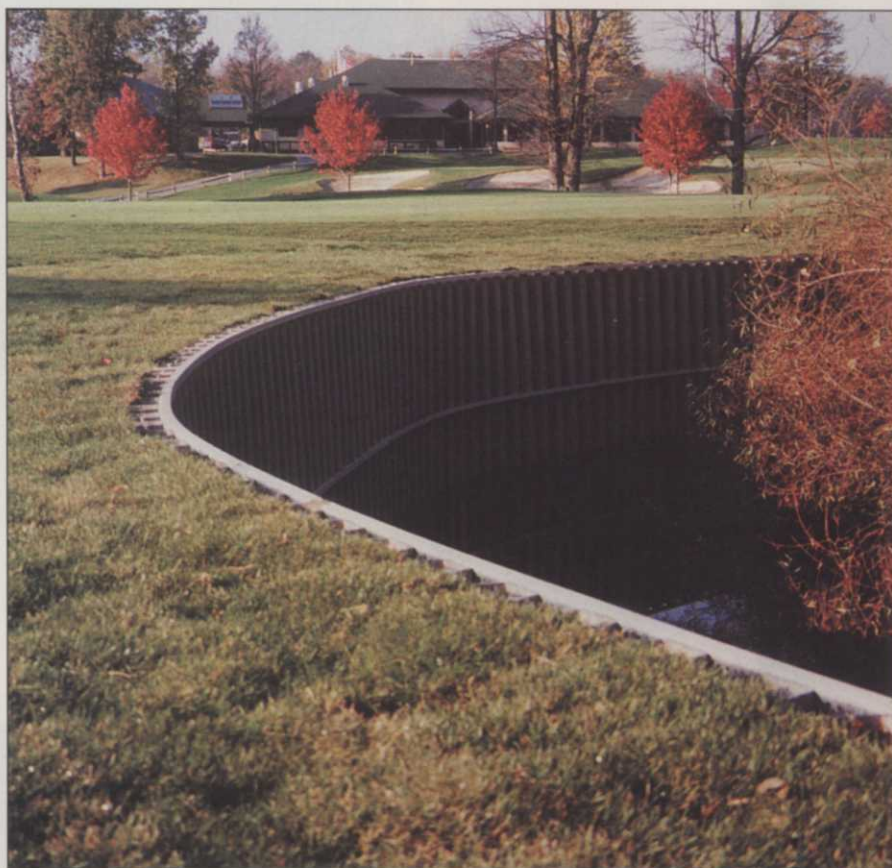
After the fill had settled, it was topped with soil and sodded.

4) Final step was to backfill the washed-out area between the new bulkhead and the eroded bank with 600 tons of #34 stone, fill dirt, finished with sod.

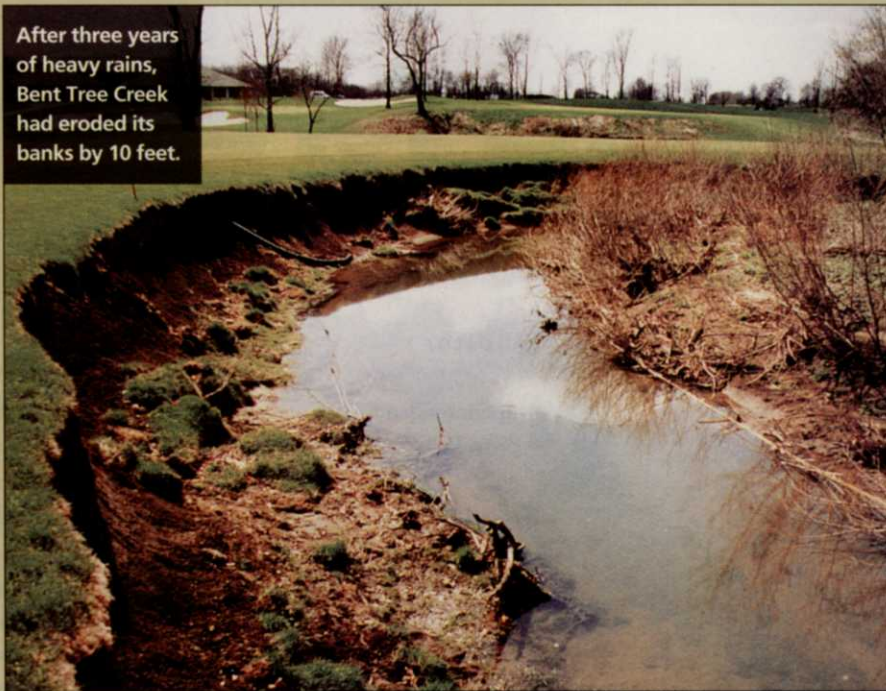
After three years of heavy rains, Bent Tree Creek had eroded its banks by 10 feet.

Three consecutive rainy seasons caused the creek to cut a channel to within a few feet of the front edge of the green, 10 feet from its original course three years ago.

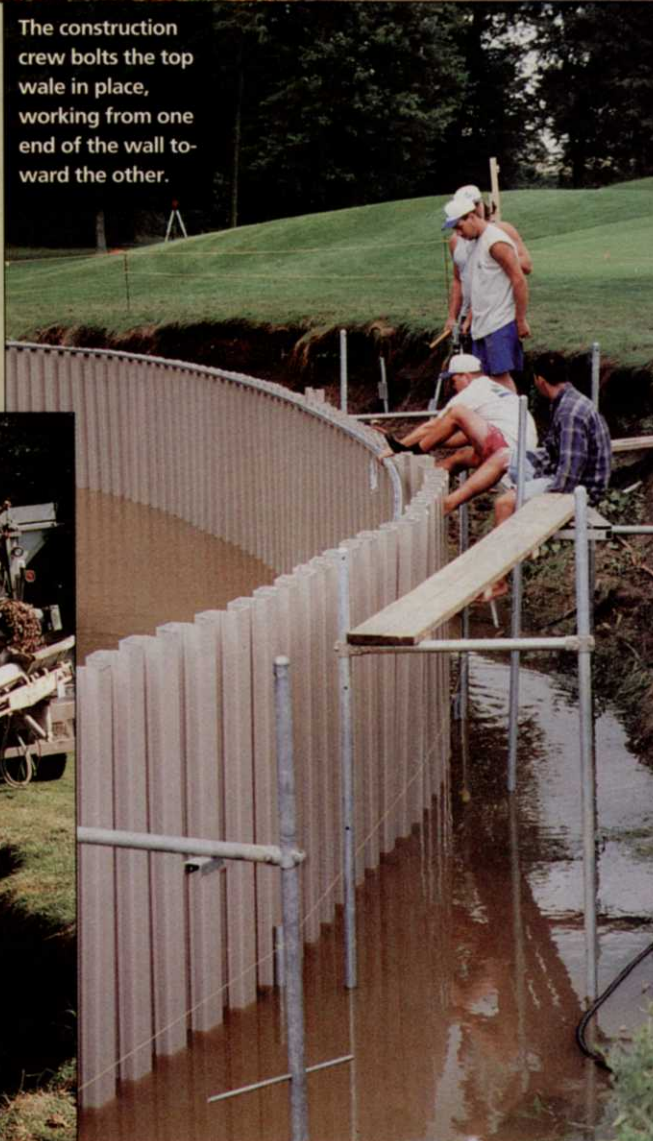
The construction crew bolts the top wale in place, working from one end of the wall toward the other.

3) Deadmen were driven into the existing bank, and secured to tieback rods, which were also bolted at the other end to the two horizontal rows of wales that provide reinforcement to the exterior bulkhead wall.

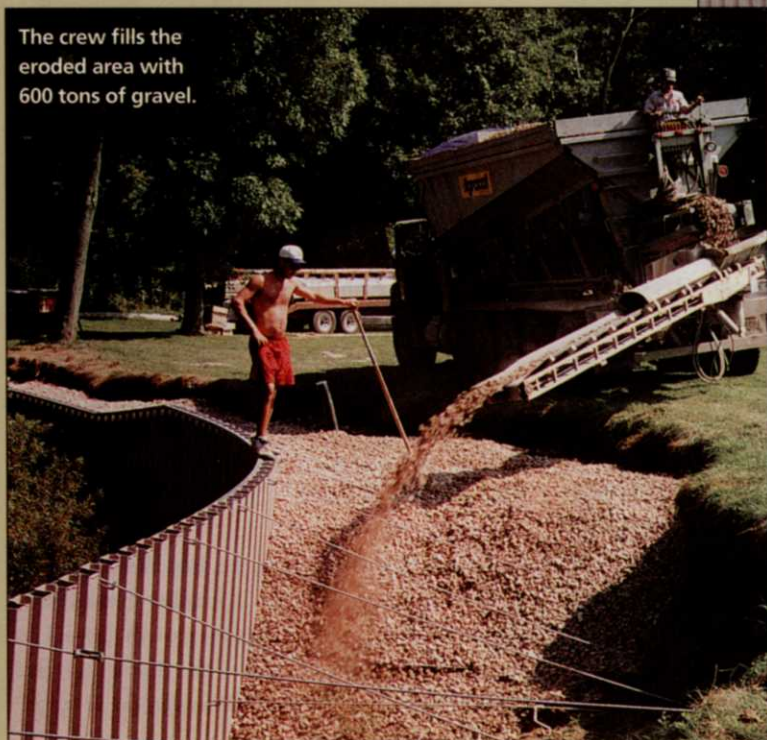
The crew fills the eroded area with 600 tons of gravel.

Dan Hickle specified the stone to make sure that runoff water that forms behind the bulkhead could find its way through the panels into the water course without building up back pressure that would stress the assembly. The four-man crew finished the job in eight days.
