Artful way to inlay

This landscape contractor combines art and technology to produce great looking patios

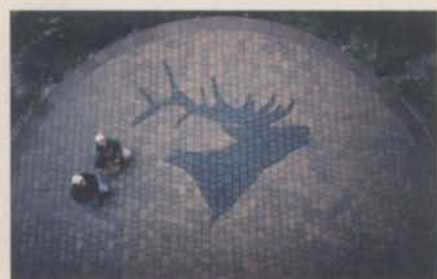
The elk head patio was dry-laid and took around two weeks to complete. First, a firm patio base was built by placing geotextile over the subsoil, which was then covered with six to eight inches of com-
Wise's elk head design looks painted or etched onto the pavers because the joints are so tight.

The most cumbersome aspect of the installation was the drawing and cutting of the elk head, which took four days. A computer-generated silhouette was traced onto the patio using a black permanent marker, and then each desert blend paver crossed by the outline was removed and cut using a diamond blade saw. To create the inset section, a corresponding charcoal paver was cut and placed along the outline. The rest of the pavers were later installed in the interior of the silhouette.

The result was an inlay that looks painted or etched onto the pavers. "The joints are so tight," says Wise, "that people can't believe it's an inlay."
