PROJECT PORTFOLIO

A SCRAPBOOK OF DESIGN/BUILD OVERHAULS

Building Community

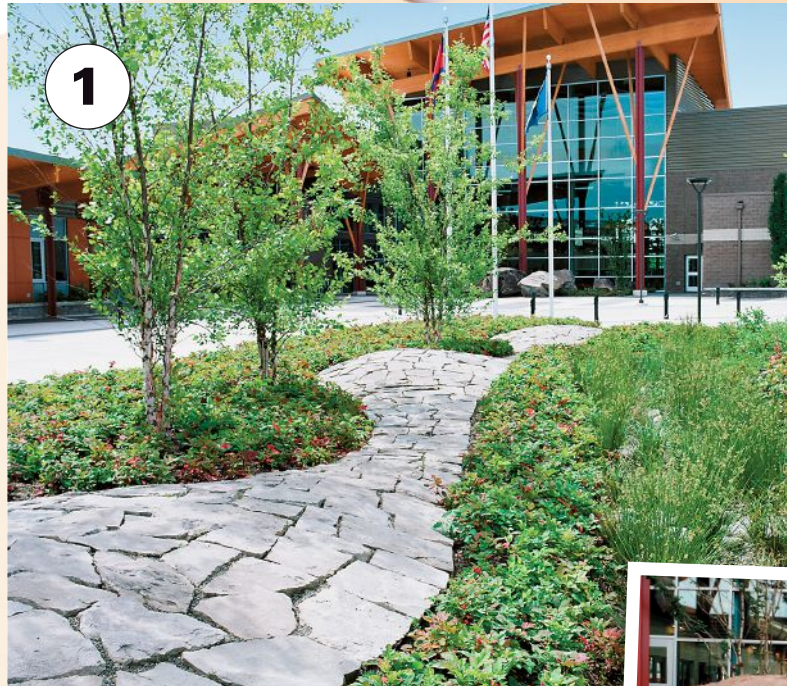
1 | Show and shell. What became known as the “turtle back” stone feature courses through a swale and planting bed near the front entry. “It is a unique feature of dry-set, three- to five-inch-thick stones laid in a rolling pathway that creates a fun element for children and adults to walk through the landscape,” says DeSantis.

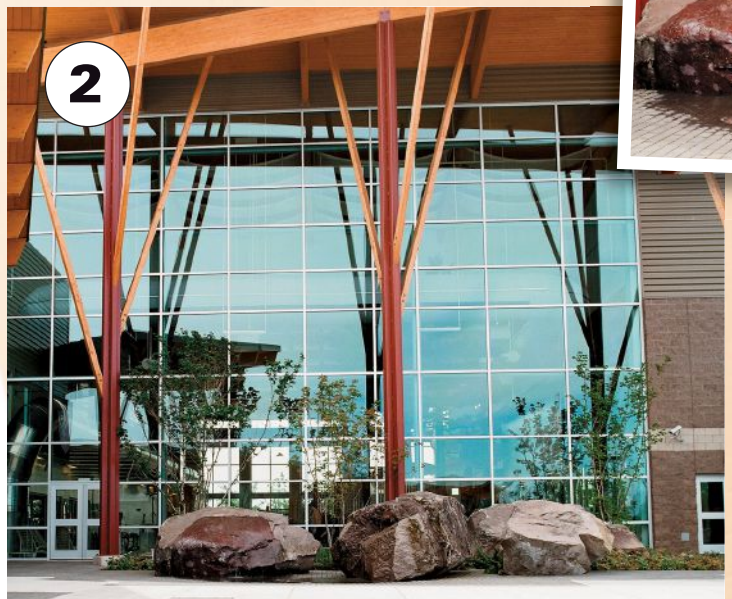
2 | Making an entrance. Behind the boulder water feature at the center’s entry are 30-ft.-tall specimen *Acer circinatum*, dug from a local, native forest.

The entry water feature consists of four boulders, each weighing between 25 and 40 tons. They were hand-selected by DeSantis and landscape architect Christopher Freshley from a mountainside in the Columbia River Gorge. A stone artist was then brought in to bore and cut the stones before they were loaded and trucked to the project site.

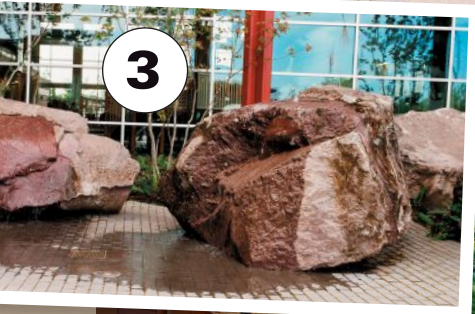
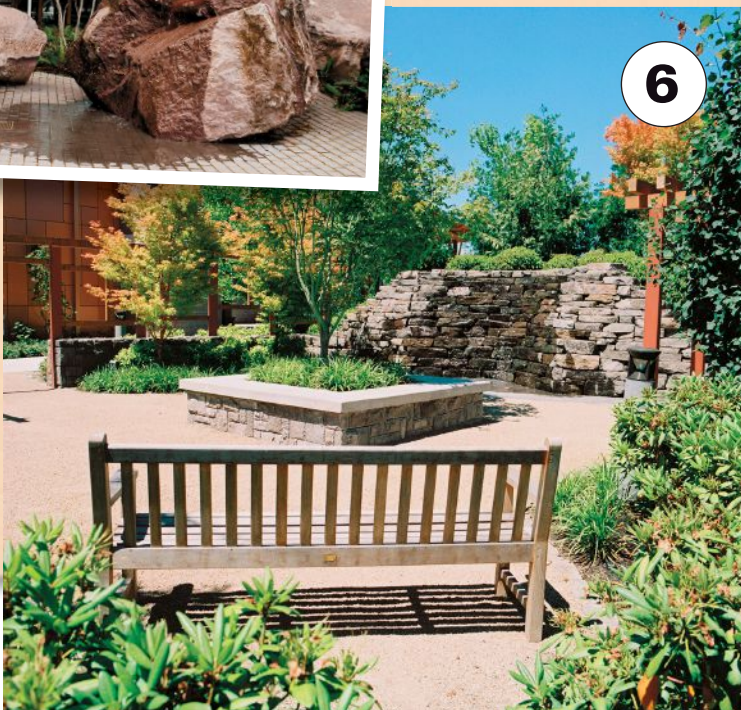
5-6 | Tranquil space. The prayer garden’s water feature is a mortared stack wall. The team was charged with keeping the water from running horizontally across the stones and directed into the basin. The solution? “All of the stones had to be laid at a slight canter,” DeSantis says, “while maintaining a nice horizontal stack line.”
